# Various notes about flooding in Whitchurch-on-Thames

## The village watercourse & other items

John Southey

March 2022

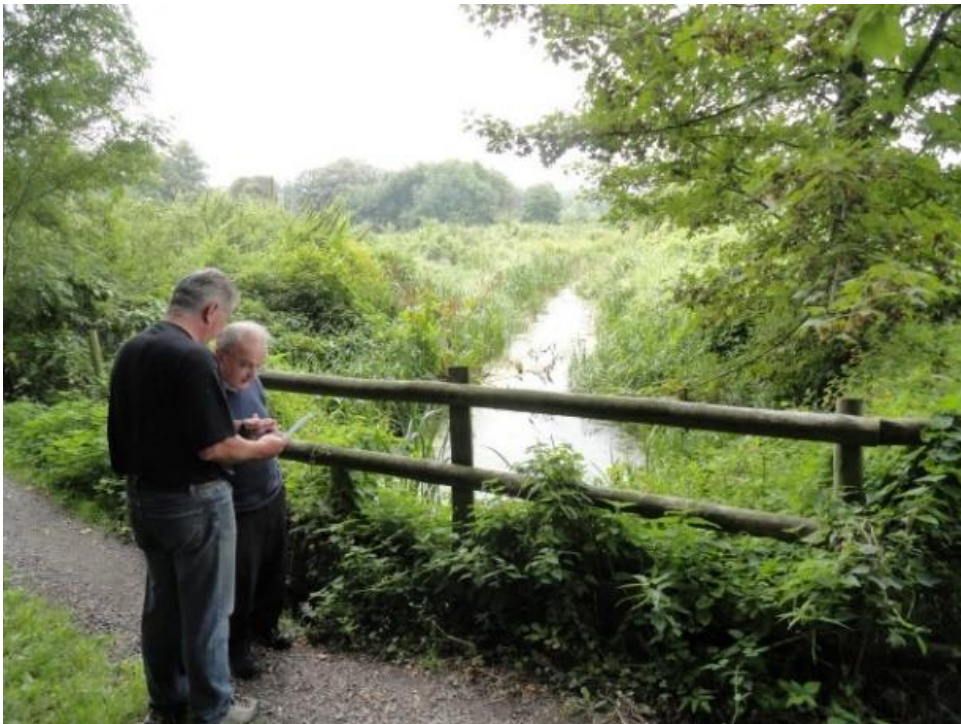
Figure 1 The large scale of the watercourse, in Walliscote farm

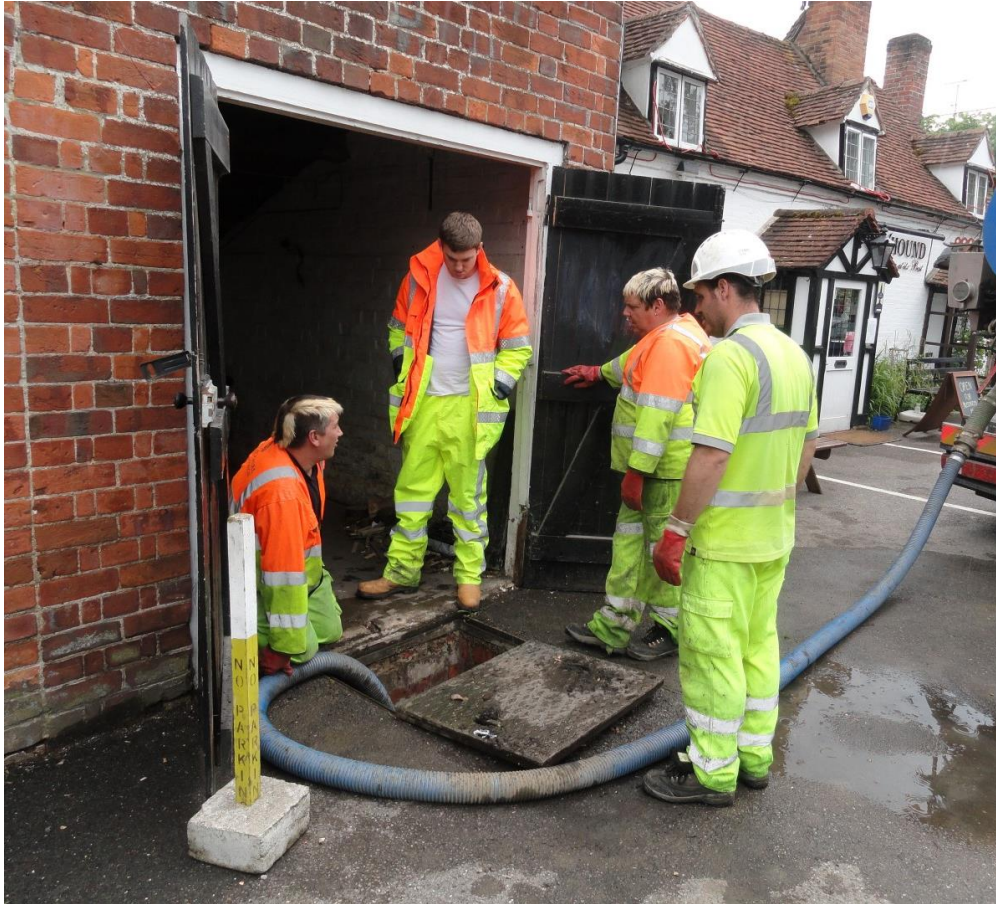
Pre-dating, and in front of and extending underneath the old fire station, is a large chamber approximately 2 m deep x 4 m long x 2 m wide, (16 cubic metres). See the photos in Figures 10 and 11.

Figure 4 – the large chamber in front of and beneath the old fire station

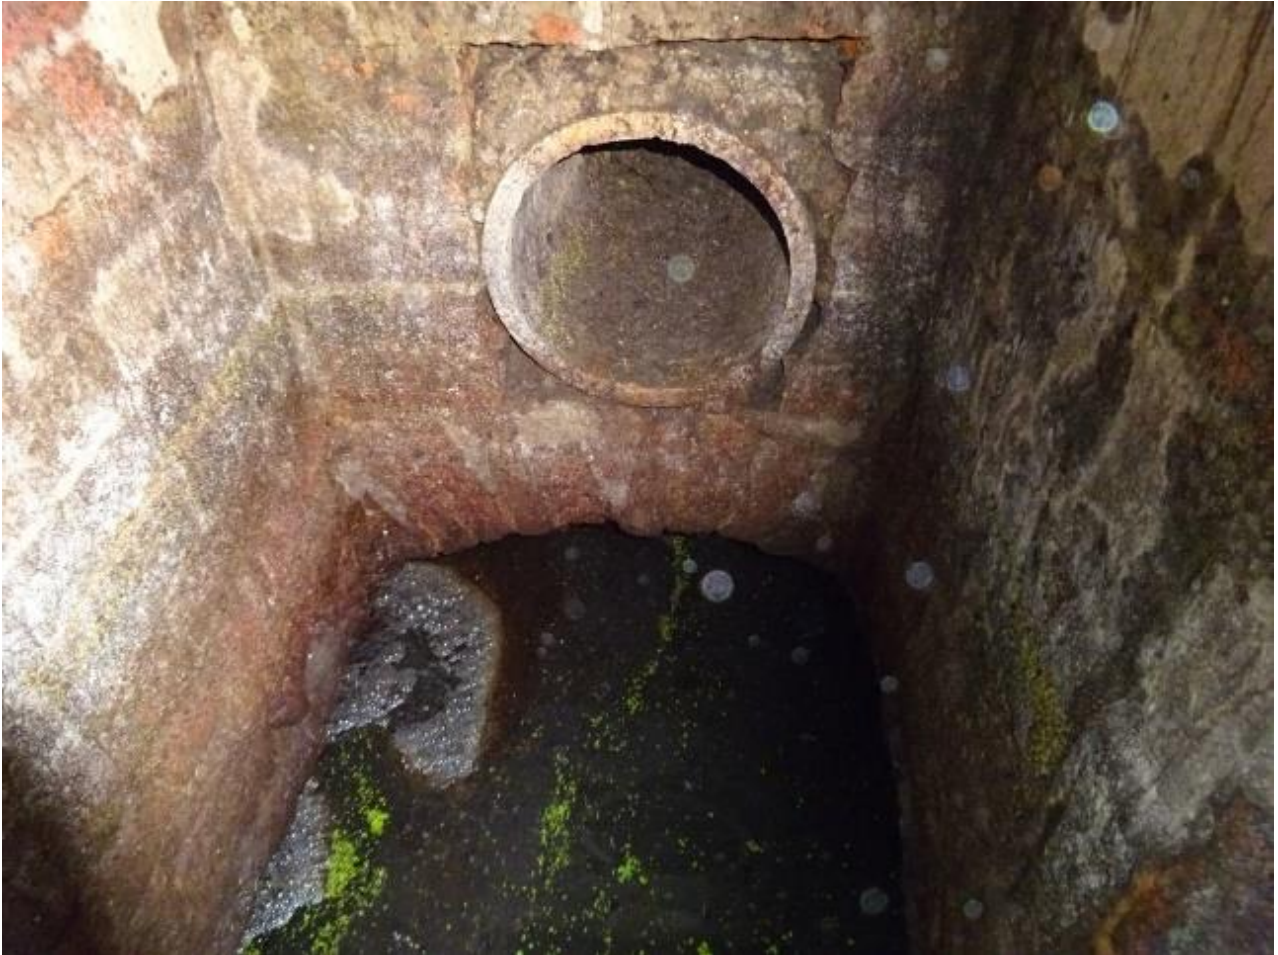
Figure 5 July 2020 photo of the chamber beneath the old fire station looking west, showing the arch of the culvert that crosses the High Street. Note the duck weed from the pond the other side of the road.

As the chamber beneath the old fire station connects directly to the pond in The Walled House it precludes a CCTV investigation unless the section under the road isolated and drained.

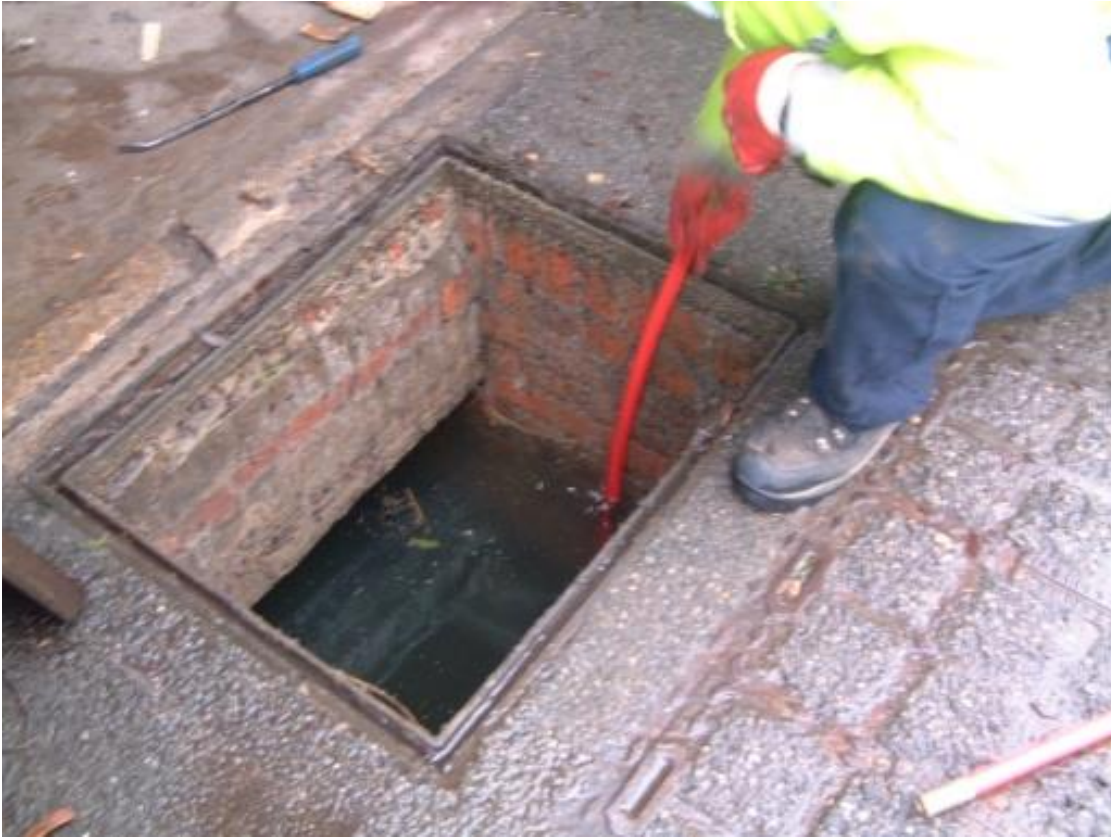
Figure 6 The 2 metre drain rod at the chamber's base. Compare the high water level in 2014 (ground water table to that of 2020 in fig 5)

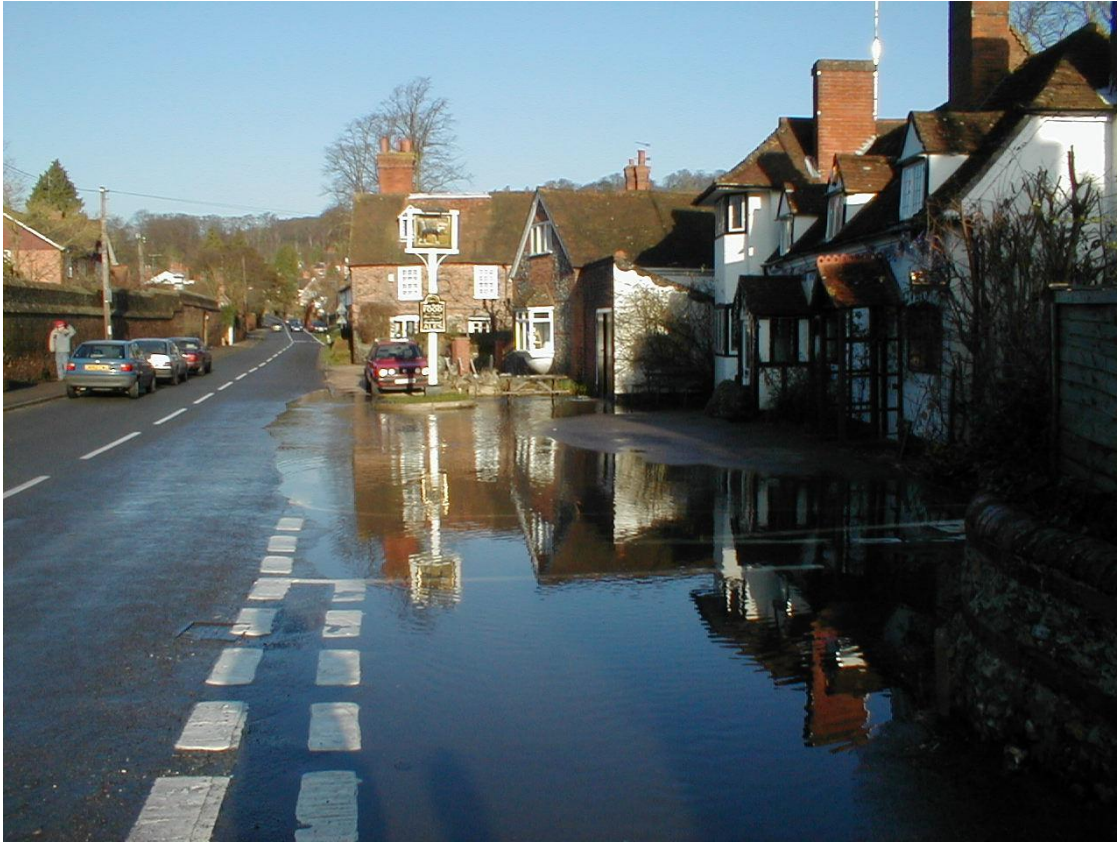
- 1) 2003 flooding of the High Street (and flooding of The Greyhound)<sup>4</sup>. Sufficient water was ejected to enable the flow to crest the watershed outside The Gables and reach the High Street .see photo below taken after the peak. Hiding in plain sight is the failure of the High Street drains. (Was not investigated until 2021).

Figure 7 2003 flooding of The Greyhound - an undersized culvert south of Eastfield Lane could not cope with the flow of upstream height Thames water causing it to eject from a roadside drain in Eastfield Lane (to the right of the photo about 100 metres away)

This was replaced by SODC after the 2003 flood using their delegated powers, (Mr Burningham was terminally ill at the time and it is not known if SODC attempted to recover their costs of the work). SODC installed a properly engineered 450 mm bore culvert, along three inspection / rodding chambers.

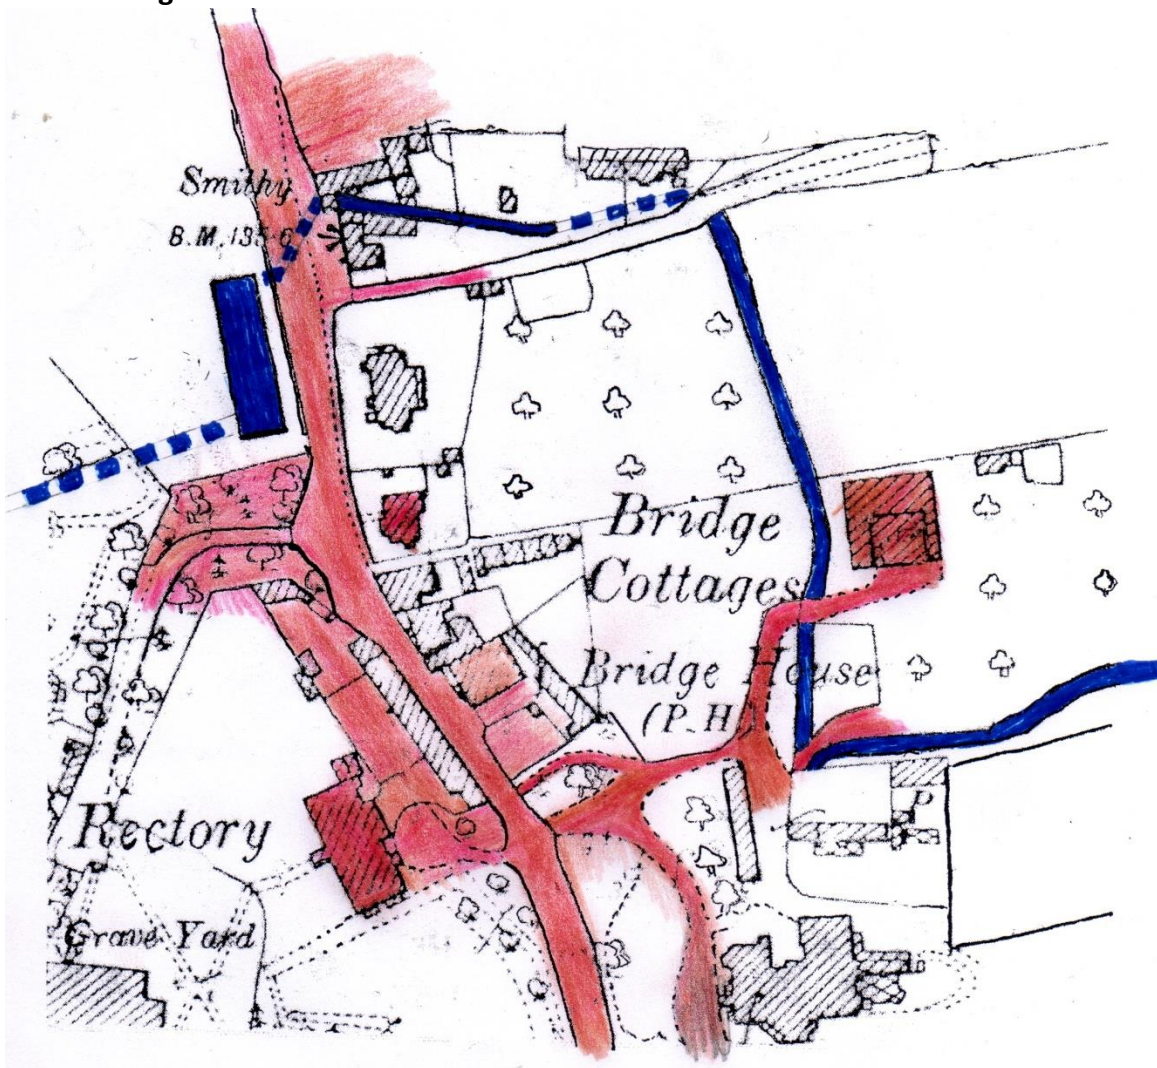
Fig 8 - Land raised following the 1894 flood, shown in red.

In other words the raised High Street means the culverted sections east of the High Street are more susceptible to a backpressure eruption from above weir height floodwater along their length if there is a restriction within the

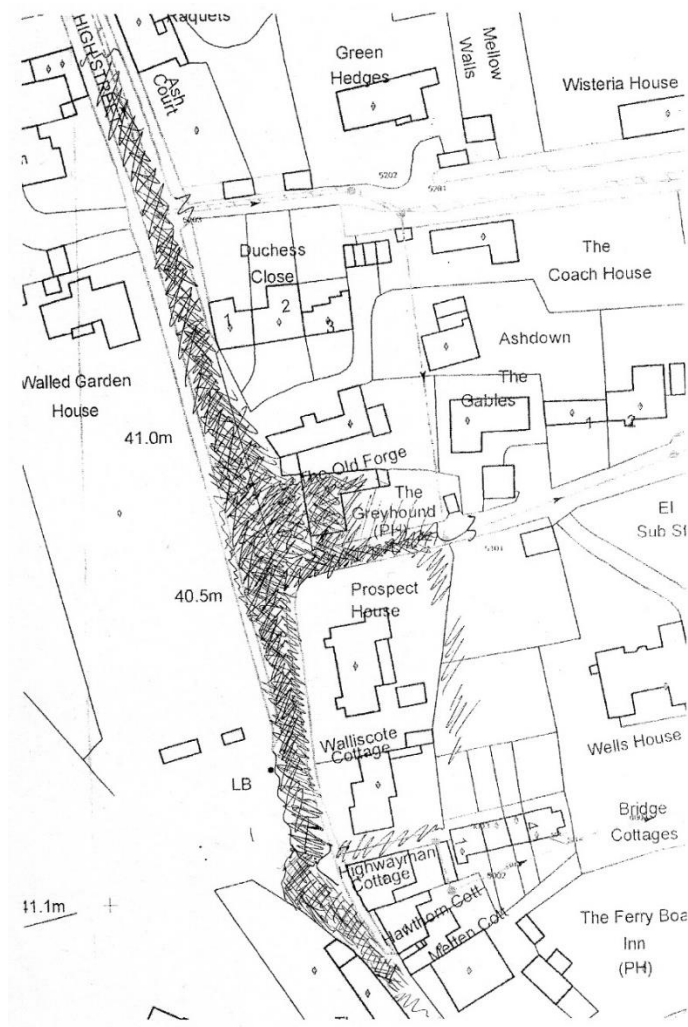
The 2020 flash flood demonstrated the large size of this depression, see Fig 2. It extends northwards almost as far as the Walliscote Farm entrance, south to Highwayman Cottage and eastwards to a watershed in Eastfield Lane near The Gables. Referred to as “The Greyhound bowl”. An estimated 400 m<sup>3</sup> of water accumulated there within 30 minutes and took some 2 hours to clear. Floodwater in the road came as far south as the Ferryboat Inn.

**Figure 16 shaded area is the extent of the 2020 flash flood, approx. 400 cubic metres**

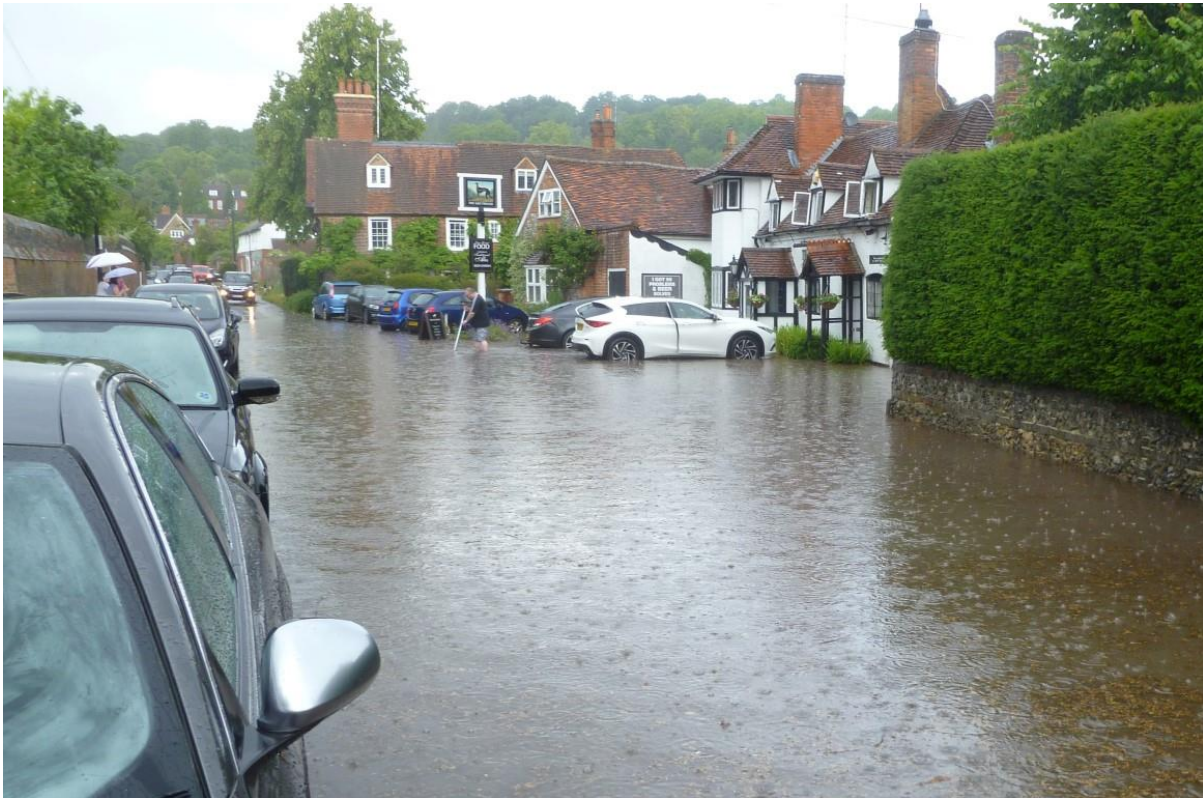
The water height of the 2020 flash flood locally outside The Greyhound was similar to the 1947 Thames flood height across the entire village. This is confirmed from comparison with the 41 m benchmark and anecdotal memory of where water ran in 1947.

**Figure 17 June 2020 flash flood – the water level approximates to the Thames flood of 1947**

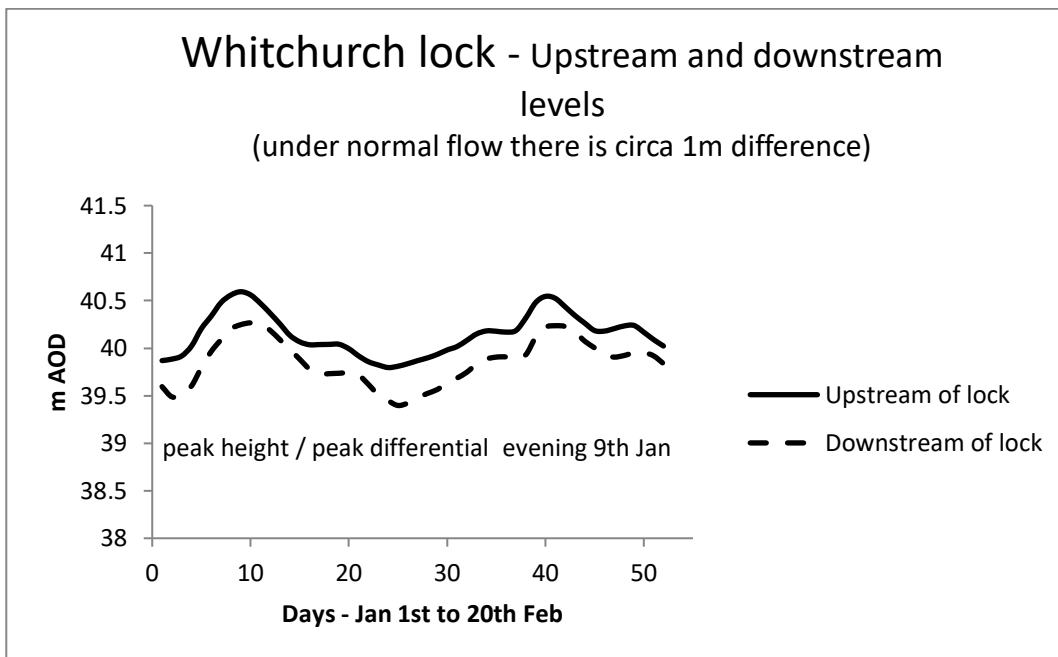
Figure 18 - River level differential during the flooding Jan / Feb. Circa 400 mm

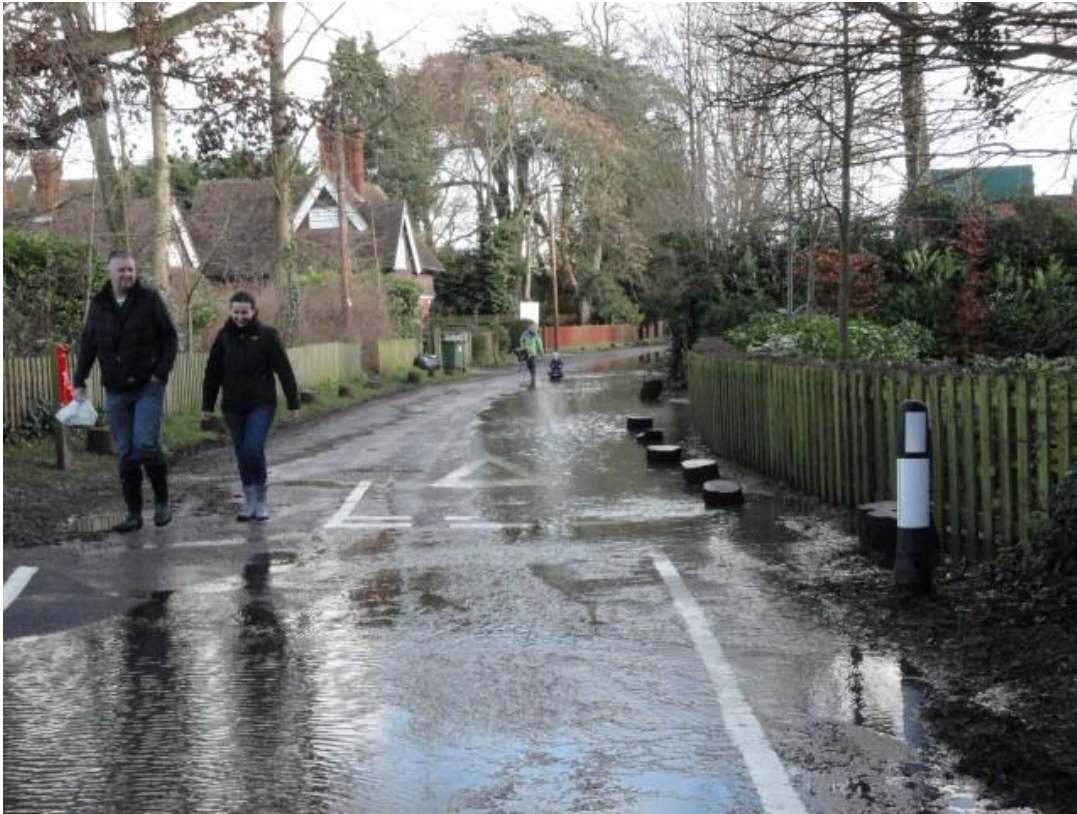
Eastfield Lane was partially flooded again for the same reason as in 2003, namely a restriction in the culverted section which caused upstream height Thames floodwater to erupt from manhole cover lifting eyes in Chiltern Edge and more significantly from the roadside drain outside that property.

**Figure 7. Flood water in Eastfield Lane, 10th January 2014.** *Note the tide mark to the north (left of photo) following the peak height at 9 pm the previous evening. This shows that virtually the entire road width was covered at the time of the peak.*
