Report on the flash flood in Whitchurch of 16th June 2020

by
John Southey and Richard Wingfield

11th August 2020

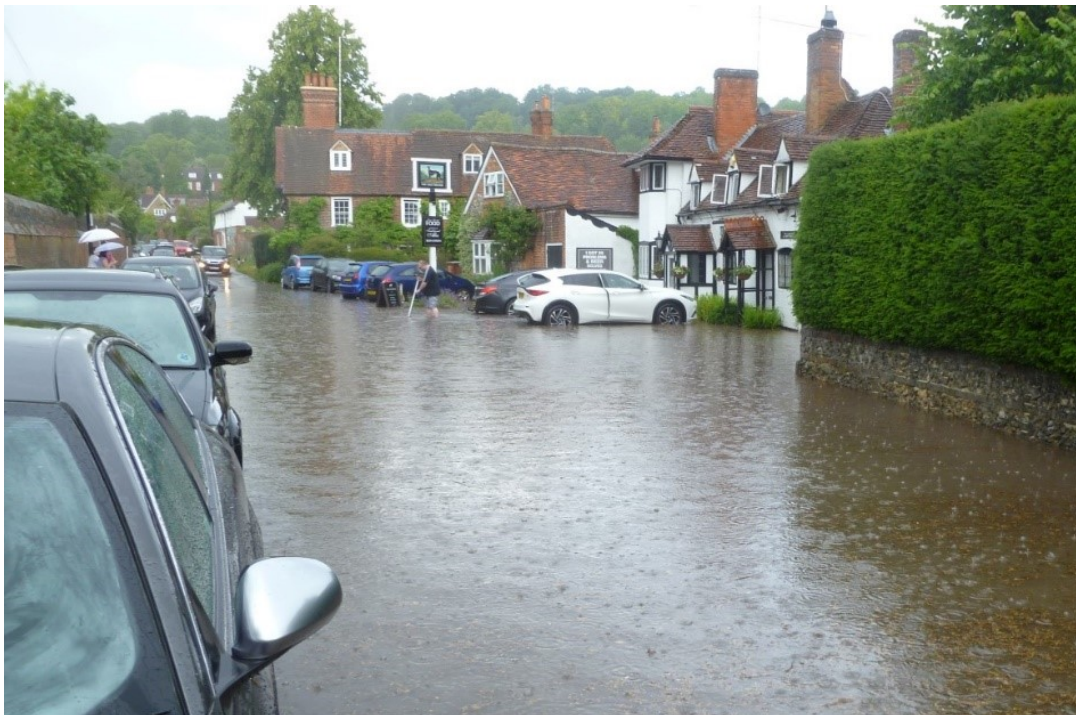
Figure 1 Low lying area outside The Greyhound at the end of the storm (rain is still falling)

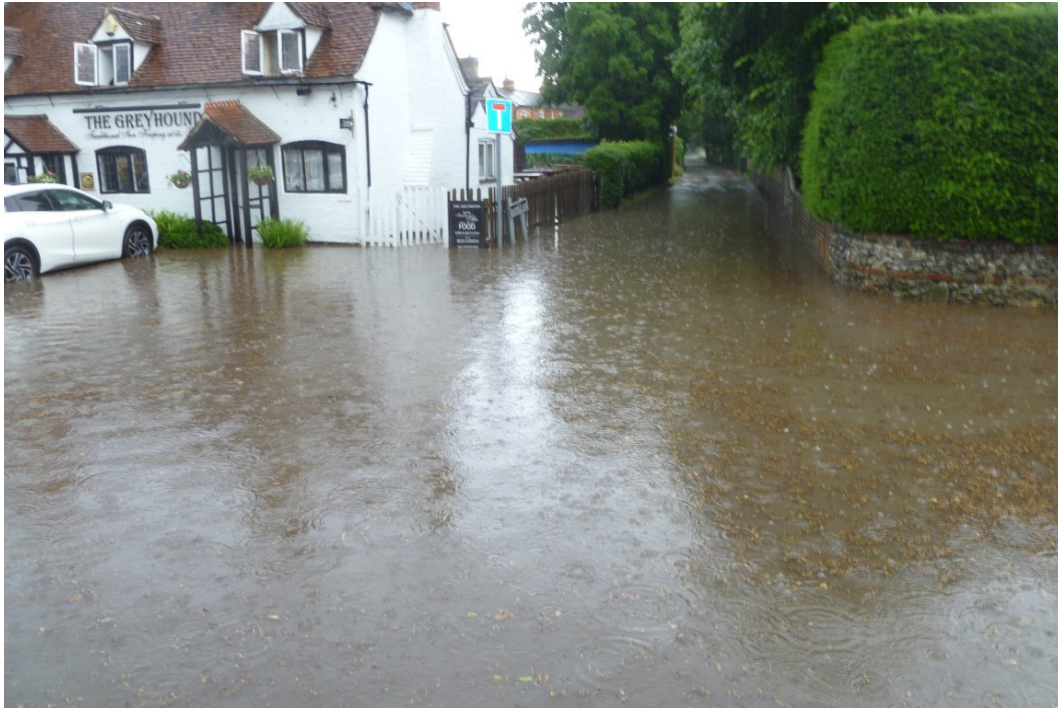
Figure 2 - Eastfield Lane was flooded as far as the slight watershed near The Gables.

In Eastfield Lane, local rainfall caused some flooding of the road, covering half of the road width in places. Blocked gratings at gullies delayed the drainage. Less silt was evident amongst the leaf litter here than in the High Street. The surface water here did not contribute to the pool forming in the Greyhound bowl as it did not cross the watershed outside The Gables. Some of the stormwater drained into the village watercourse, as shown in Figure 8.

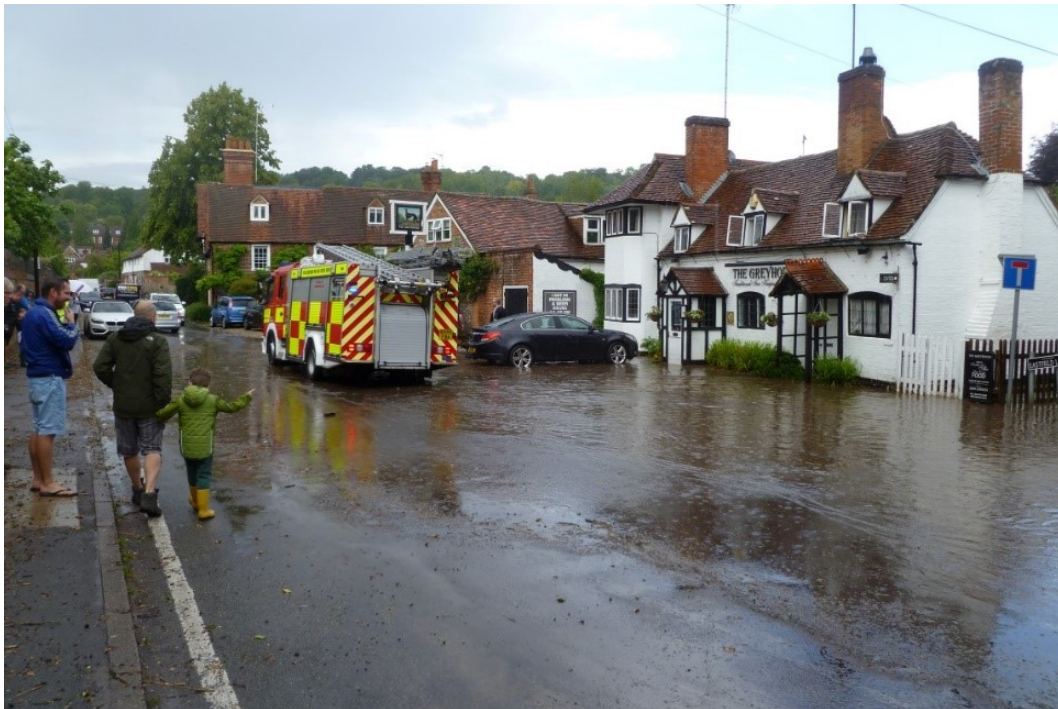
Figure 3 - The Fire Service attended shortly after the storm.

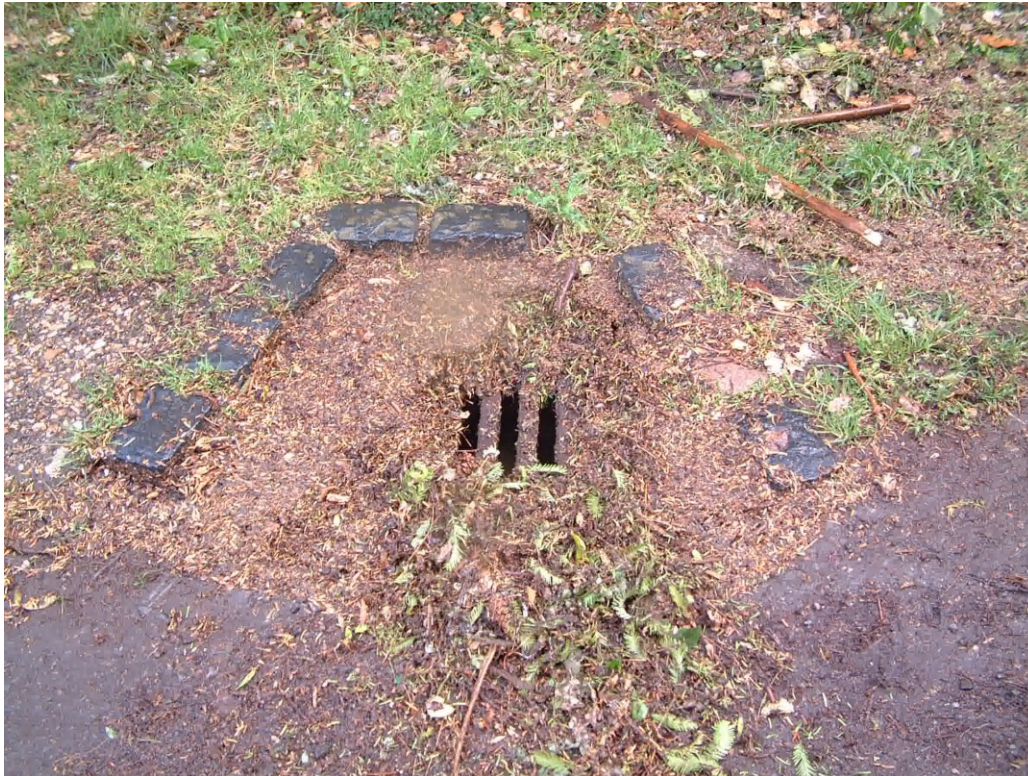
It could be seen that floodwater coming down the hill was unable to drain away through the roadside stormwater drainage system, partly because the gratings over the inlet gullies had quickly become blocked by the exceptionally large amount of leaf litter in the flow. The vegetable matter mixed with the silt and sand in the water, tending to create a solid plug. See Figure 4.

Figure 4 - A drainage gully after the storm. The leaf litter build-up, partly cleared by hand, can be seen. This gully is in Eastfield Lane.

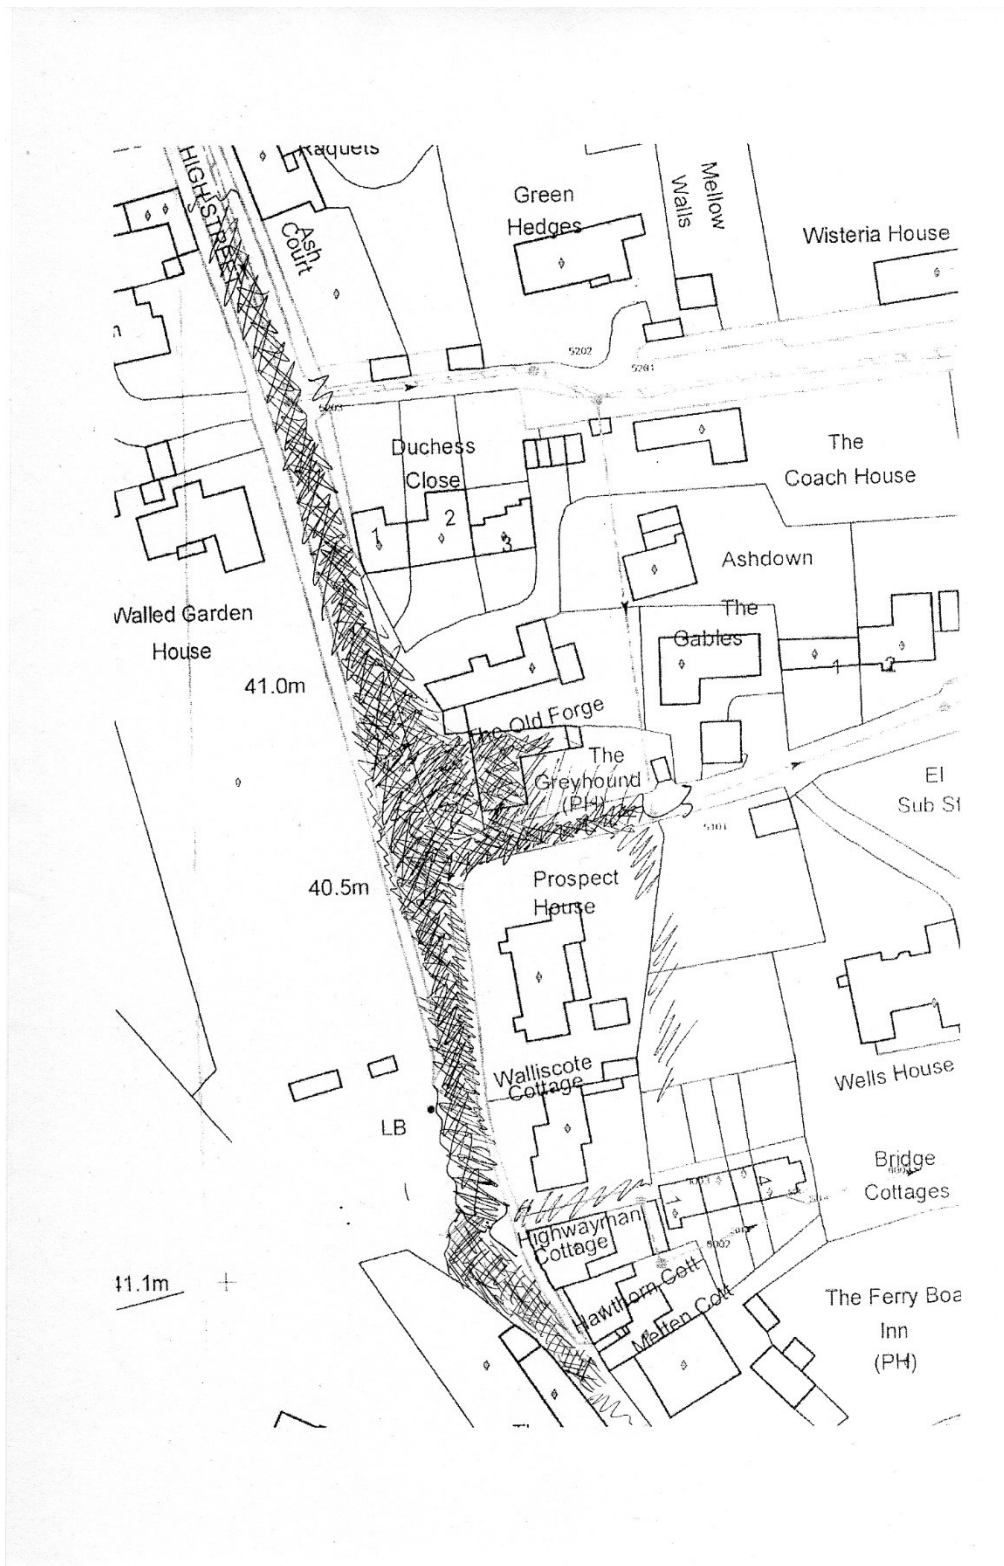
The extent of the pool of water is shown in Figure 5. An estimate of the surface area of standing water is 1500 sq. metres. With an observed maximum depth of about 350 mm for the lower part of the Greyhound bowl, an average depth of 250 mm can be assumed. This gives a volume of about 400 cubic metres. It took about 30 minutes for the water to arrive. It took around two hours to subside, once the leaf litter was cleared from drainage gullies. Some of the water would also have drained naturally into gardens etc.

Figure 5 – Extent of the pool of water in the Greyhound bowl.

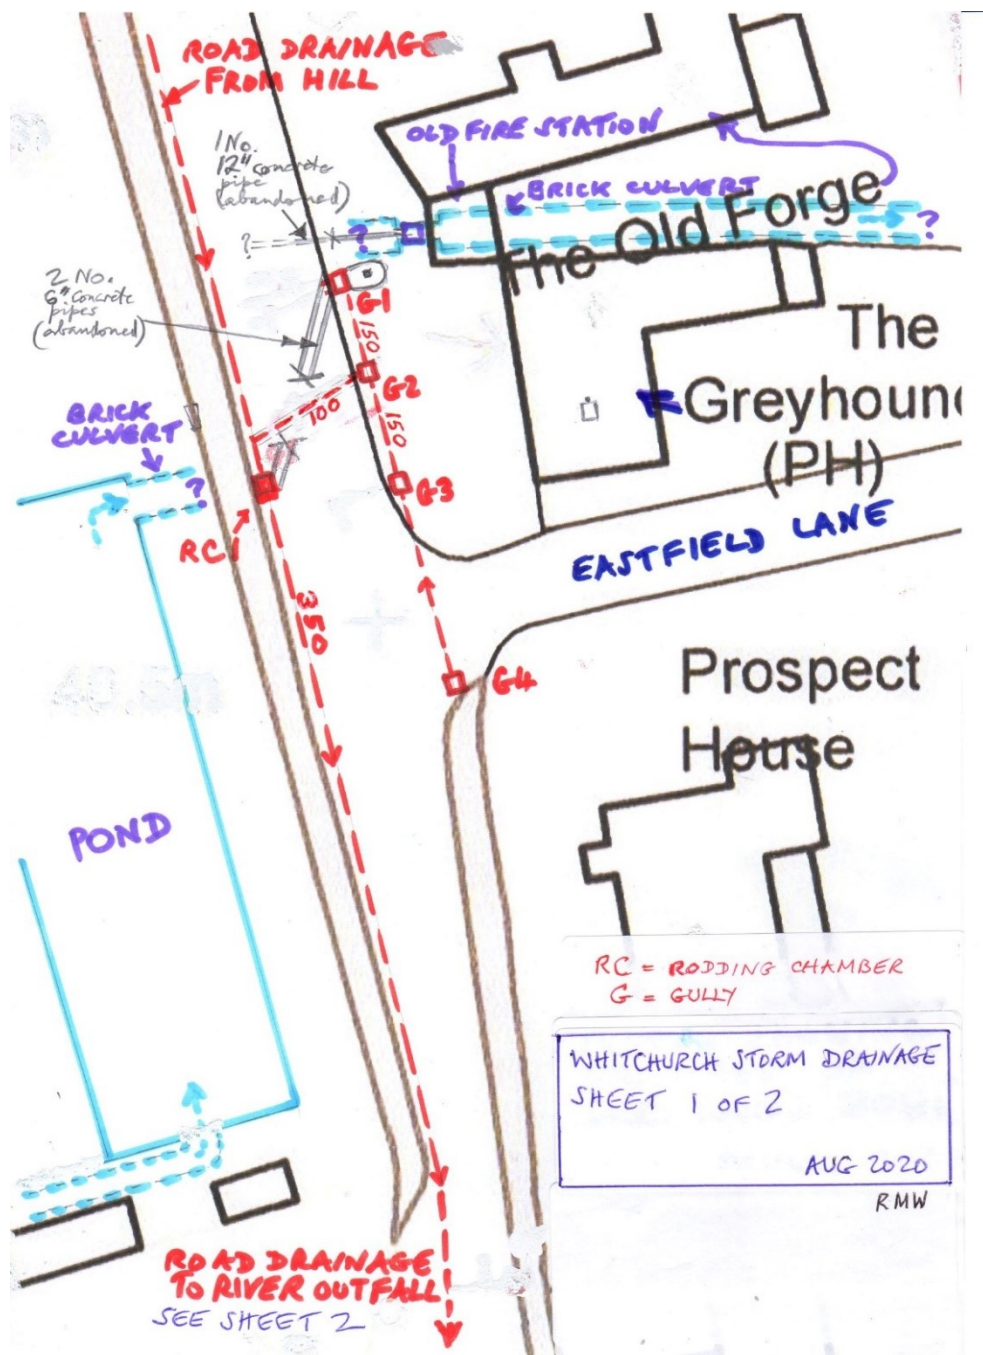
Figure 6 — Sketch of storm drainage network, Sheet 1 of 2

G1 to G4 - located on the lower-lying side of the street, these are designed to protect The Greyhound and neighbouring houses. G1 has an open side entry, the others have gratings. Only G2 seems to provide the essential route to the main drain on the other side of the road, and that is a surprisingly small 100 mm diameter pipe. It joins the main drain in a 'blind' location which is difficult to inspect.

G1 includes two concrete pipes crossing diagonally towards RC1, where they are also visible. These are blocked and abandoned. They must represent an earlier attempt to drain the Greyhound bowl.

Just to the north of G1, the chamber at the old fire station has a blocked and abandoned concrete pipe entering from under the road. This may represent a historic attempt to divert road drainage water into the village watercourse.

The exact route and condition of the brick culvert carrying the village watercourse under the road in this area is at present unknown.

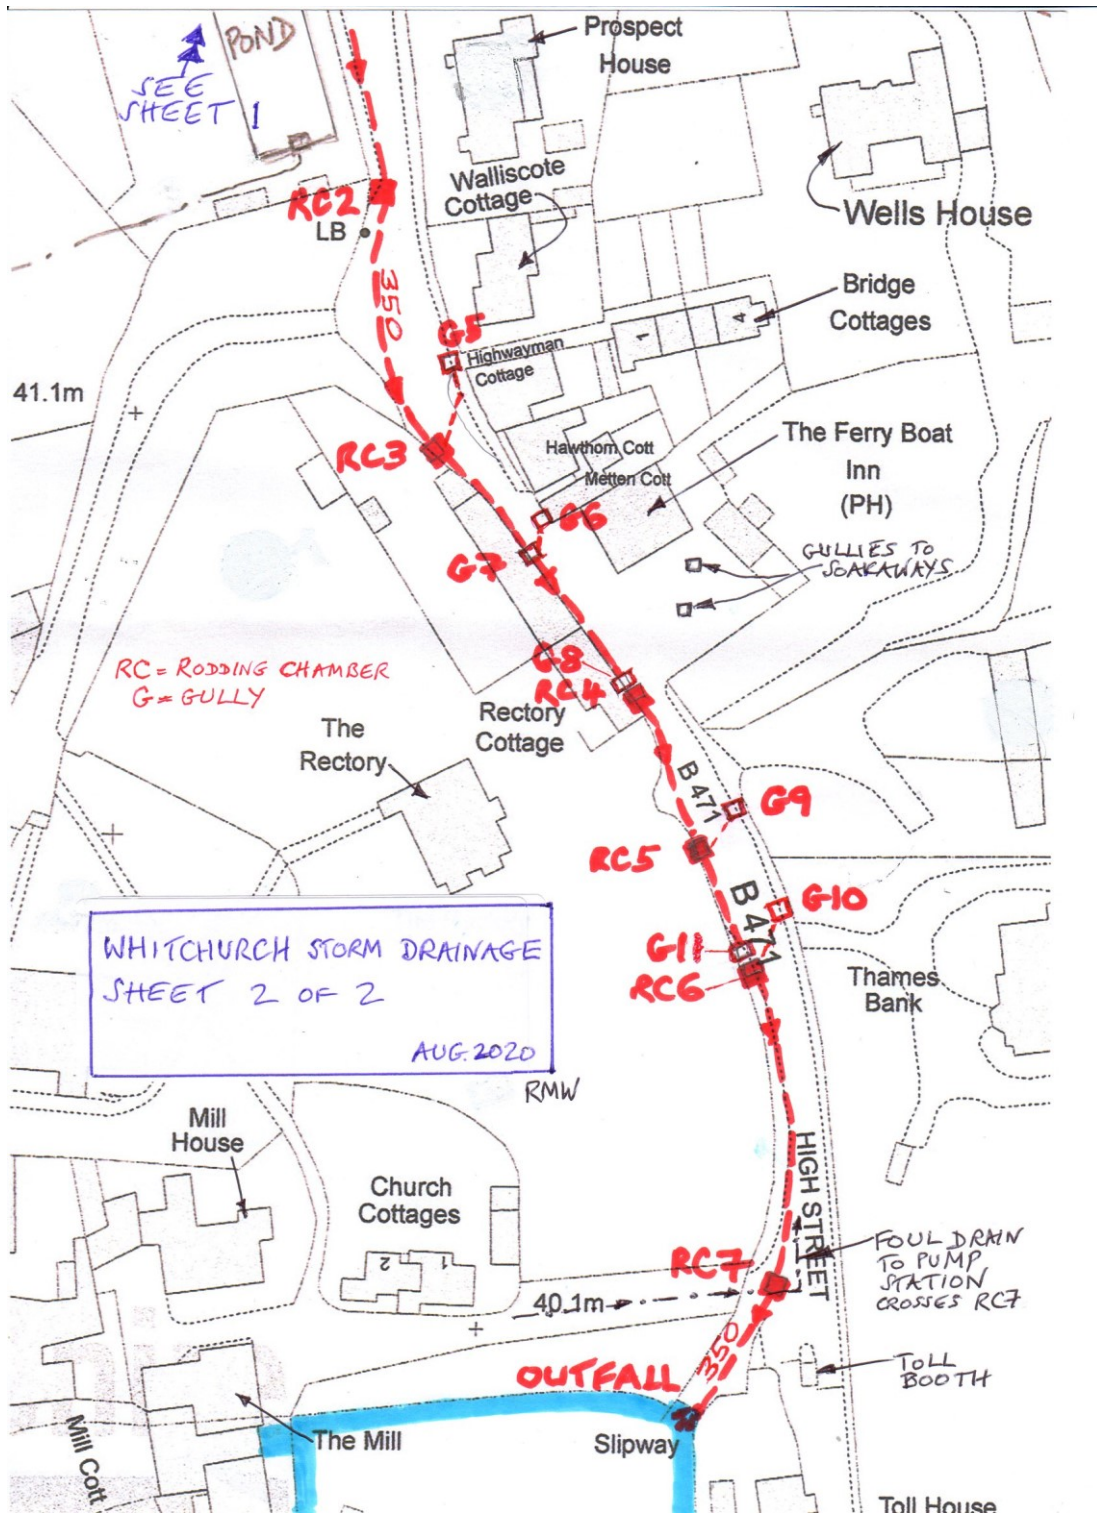
Figure 7 — Sketch of storm drainage network, Sheet 2 of 2

G5 – this was relocated further north by a few metres when the footpath was widened for traffic management reasons in the 1990s.

RC7 – Near the bottom of this deep manhole there is a surprise. The pipeline taking sewage from the Mill area to the pumping station in Eastfield Lane crosses through the manhole, obstructing the stormwater flow and causing a build-up of silt and debris which needs regular removal.

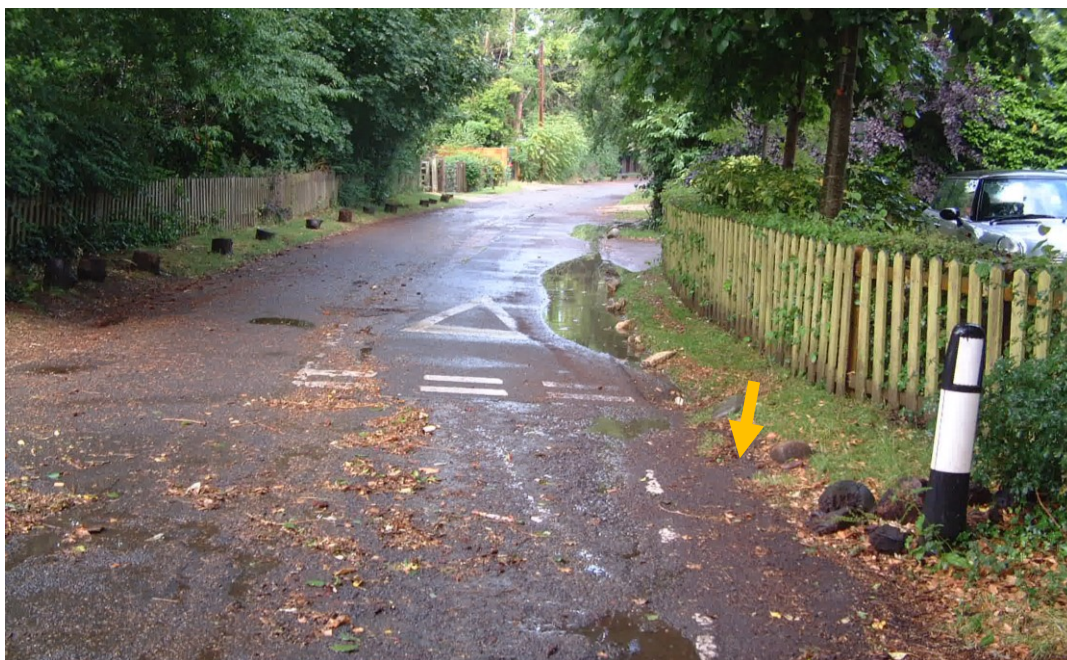
Figure 8 – After the storm, showing the road drainage gully (arrow) in Eastfield Lane, outside Chiltern Edge, which leads down to the culverted village watercourse.
