Report on river flooding in Whitchurch-on-Thames in January and February 2014

Updated edition, 10th August 2020

by
John Southey and Richard Wingfield

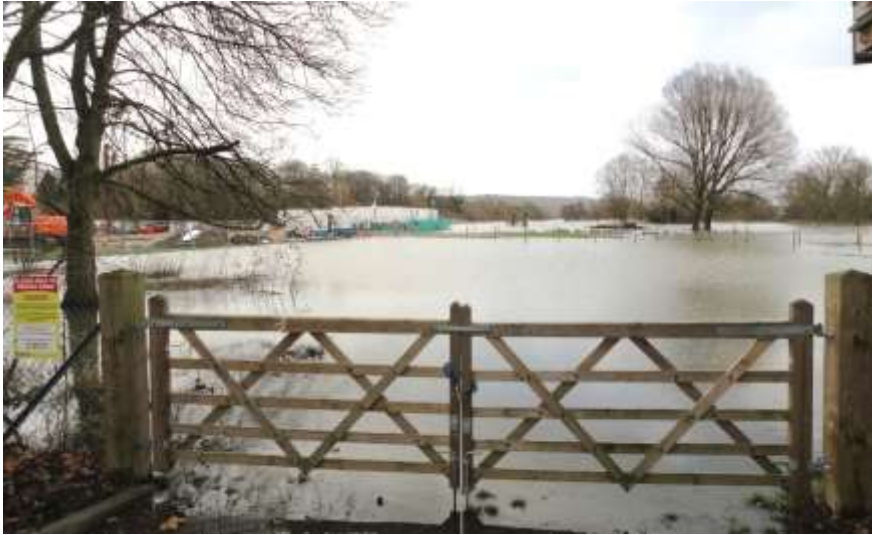
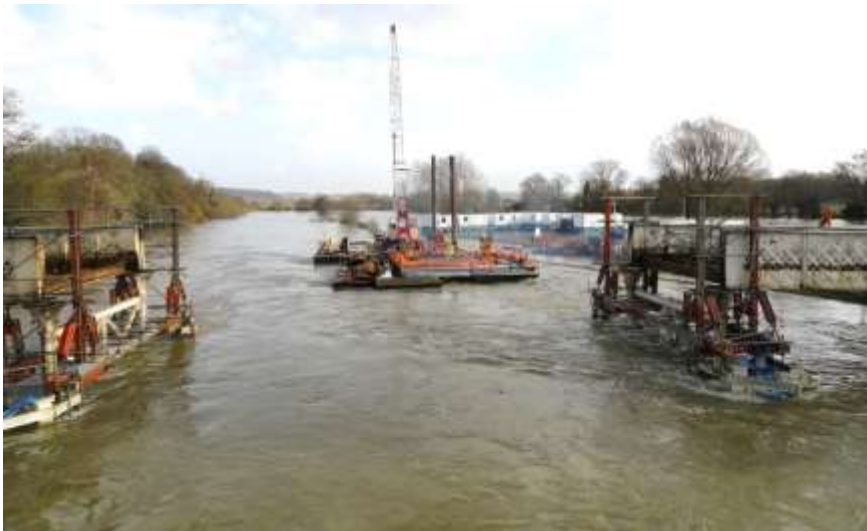
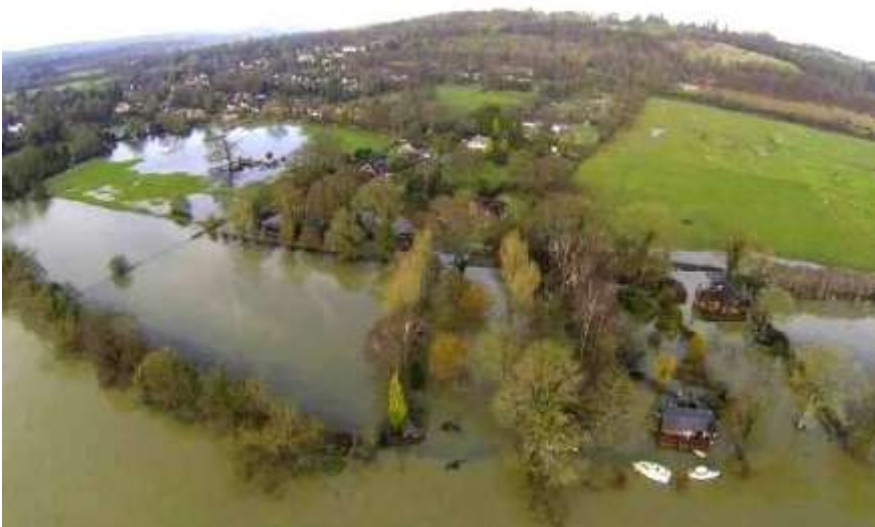
Figure 1 - Views of the river in flood, January 2014. Upper, from the Dolphin Centre car park; middle, from the temporary pedestrian bridge; lower, Eastfield Lane from the air

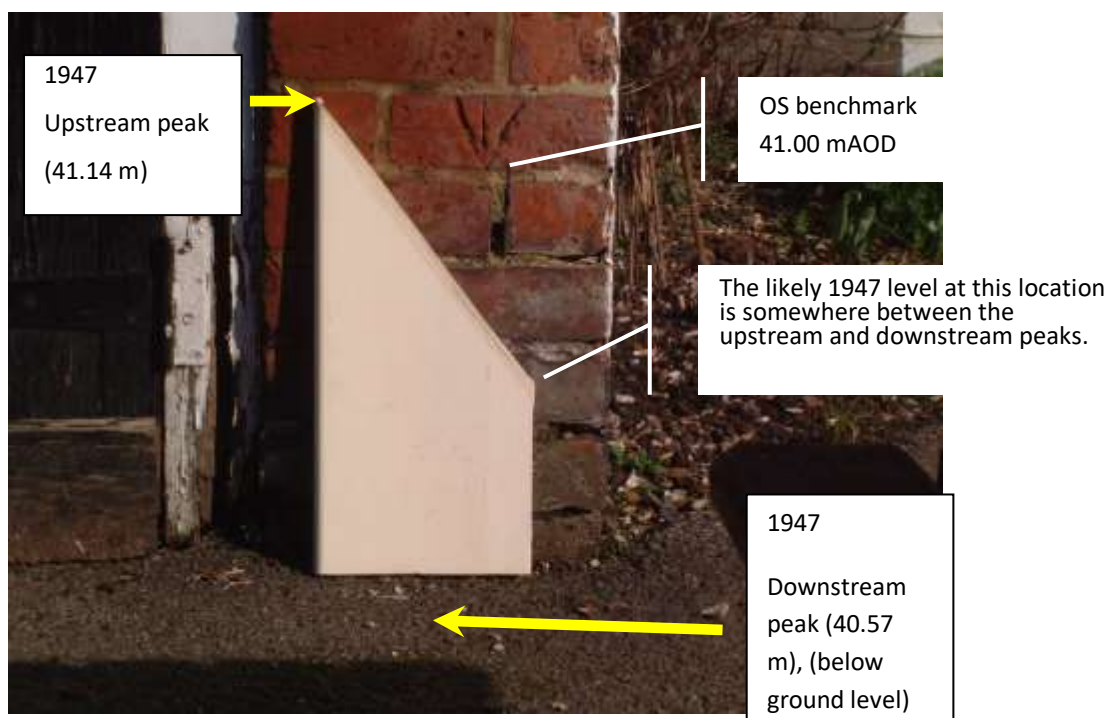
Figure 2 – Estimating the 1947 flood level at The Greyhound

Figure 2 also shows an estimate of the peak water level in 1947. It could not have been lower than the downstream river peak level, nor higher than the upstream. The assumption that it was about midway between those levels seems reasonable.

The authors would like to suggest that a flood marker for the 1947 event should be made and fastened to the wall at The Greyhound to remind residents of the flood risk.

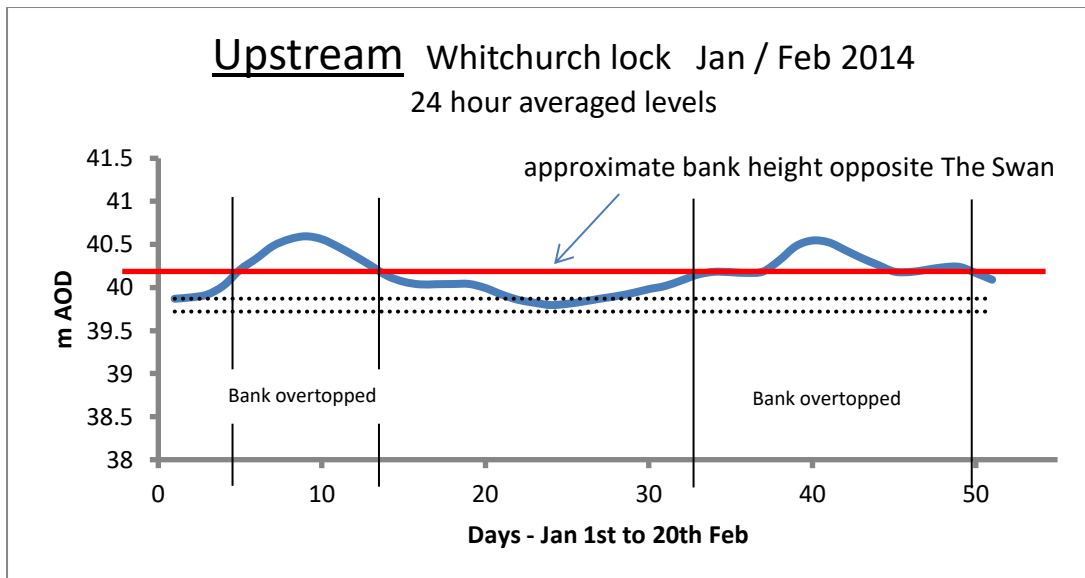
Figure 3 – Two periods when the bank upstream of the weir was overtopped

In Figure 3 the range of normal river levels is shown by the pair of dotted lines.

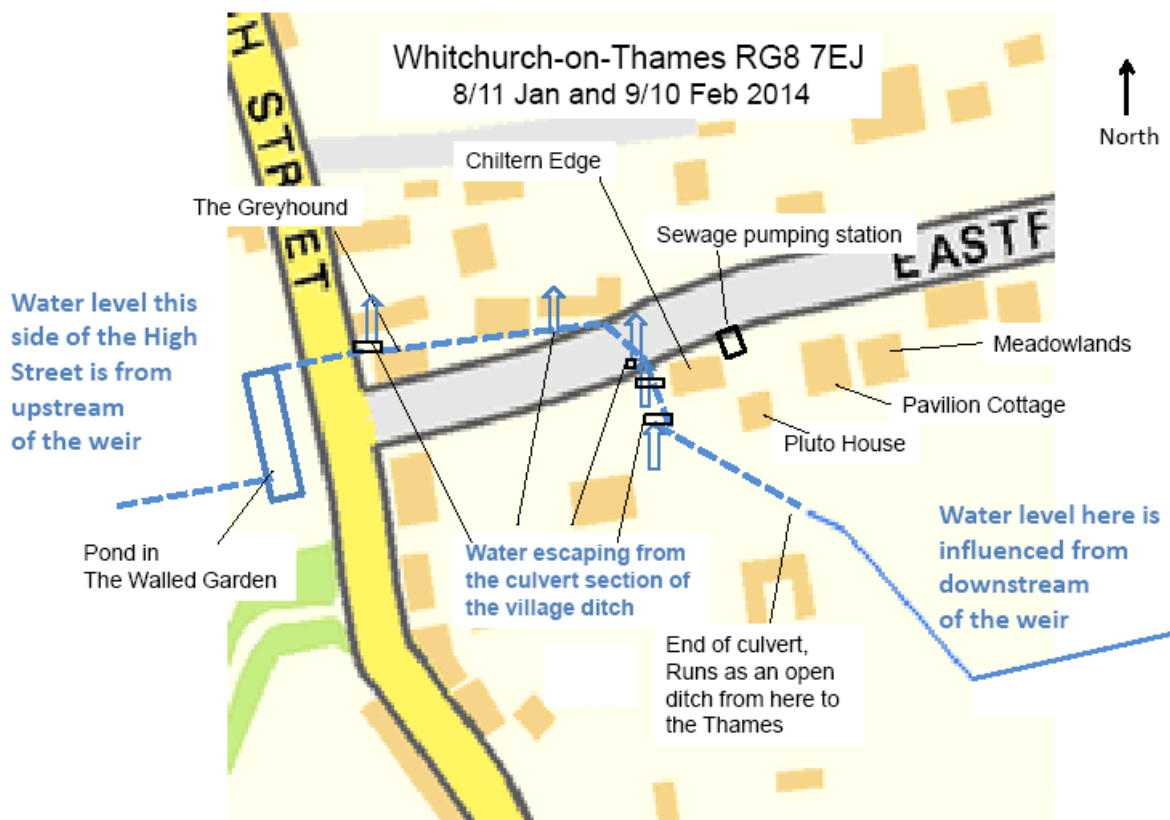
During the flood, river water flowing along the village watercourse from above the weir (and therefore under the influence of the higher river level upstream of the weir) emerged from drains at:-

- The large manhole cover outside the old fire station in the High Street
- One, possibly two road drains in Eastfield Lane
- A manhole cover in the front garden of Chiltern Edge
- A manhole cover to the side of Chiltern Edge
- A manhole cover in the rear garden of Chiltern Edge

Figure 4 – Street plan showing (in blue) the route of the culverted village watercourse and where floodwater emerged

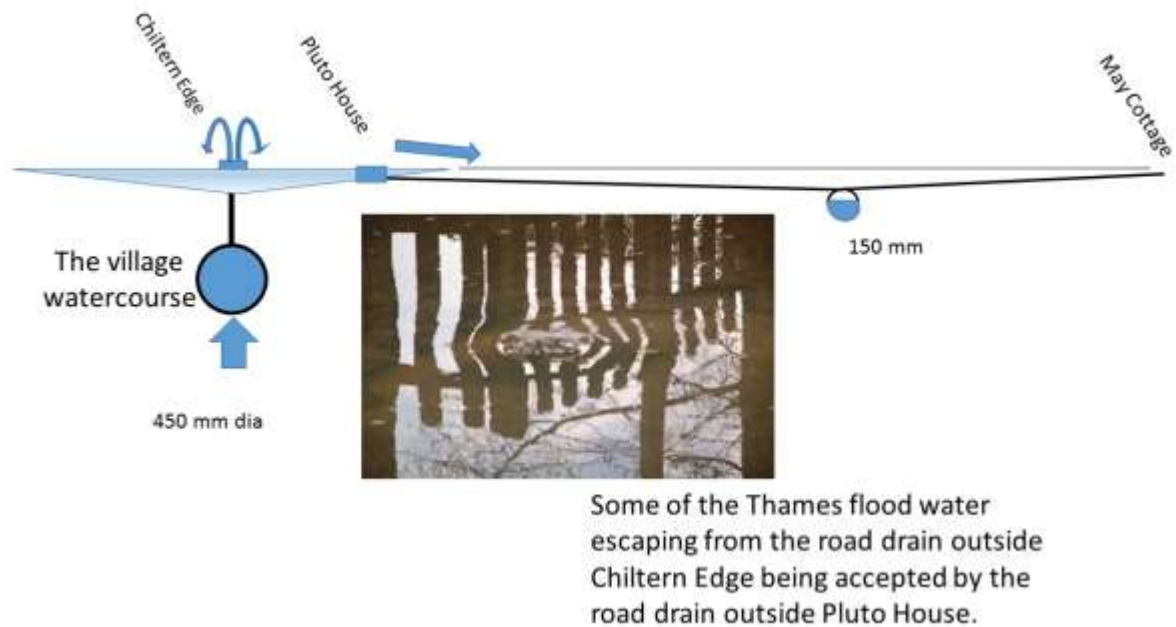
Figure 5 - Schematic of the two road drain systems in Eastfield Lane, looking north

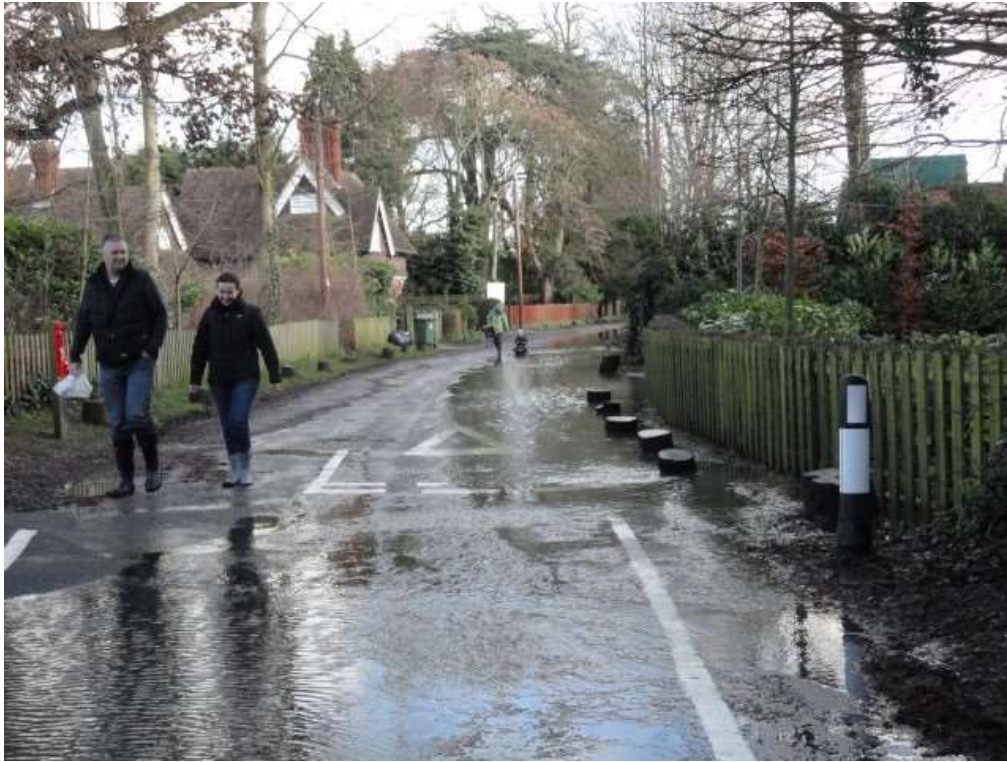
Figure 6 - Floodwater in Eastfield Lane on 10 January 2014

The tidemark visible in Figure 6 indicates that the floodwater was close to flowing over the watershed outside The Gables and then threatening the High Street.

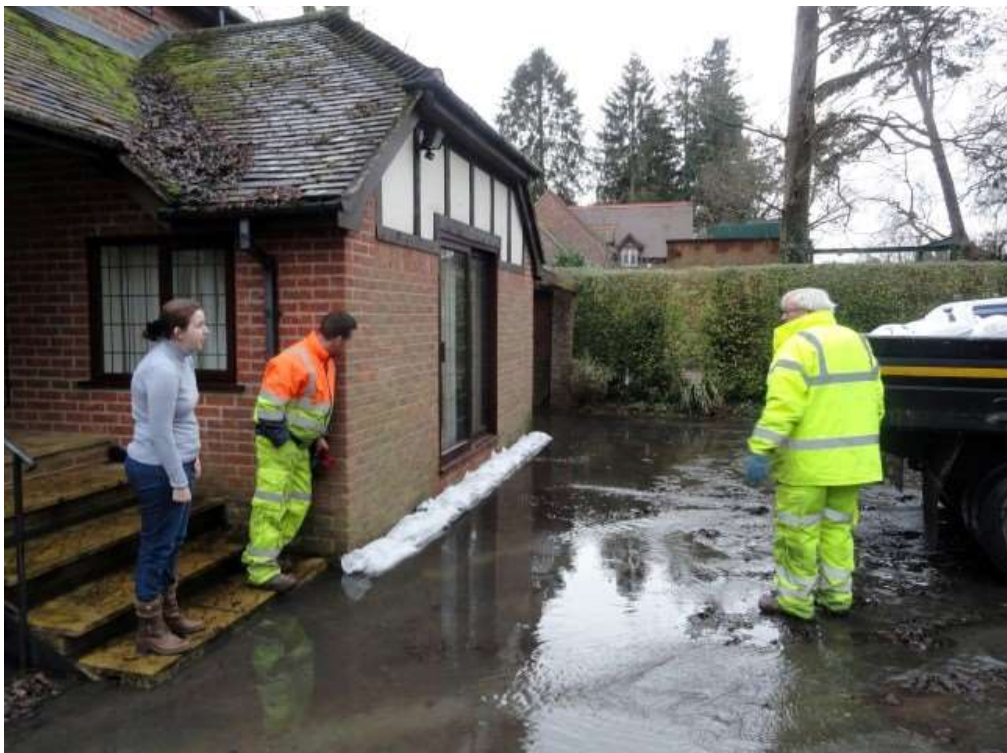
Figure 7 - Water from the restricted culvert flowing around the garden level room of Pavilion Cottage, Eastfield Lane

In Figure 7, the downstream-influenced water level in the back garden, to the left of the picture, is around 400 mm lower than the upstream-influenced level of water flowing out of the culvert and down into the front garden.

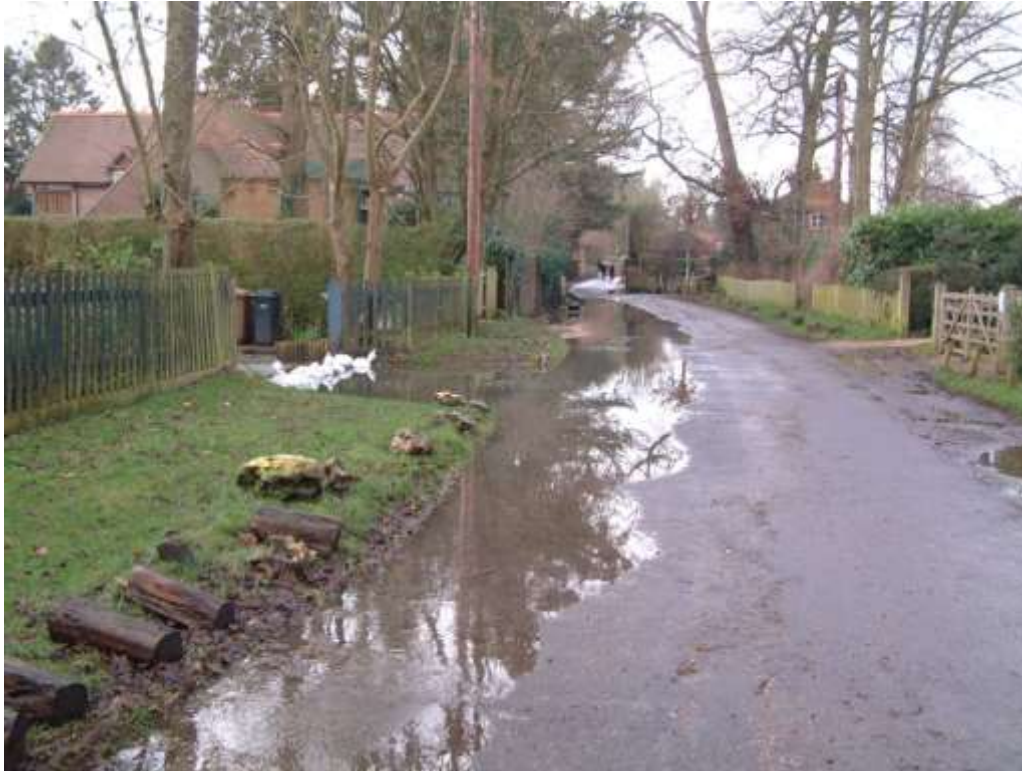
Figure 8 – More effective use of sandbags to divert water during the February 2014 peak

Figure 8 shows water from the partly blocked culvert being successfully diverted from running into the front garden of Pavilion Cottage by sandbags laid across the entrance.

With the benefit of hindsight, this was partly a road drainage issue and should have been brought to the attention of OCC Highways to solve, in addition to using SODC's sandbags to alleviate the symptoms.
