# Various notes about flooding in Whitchurch-on-Thames

## The village watercourse & other items

John Southey

March 2022

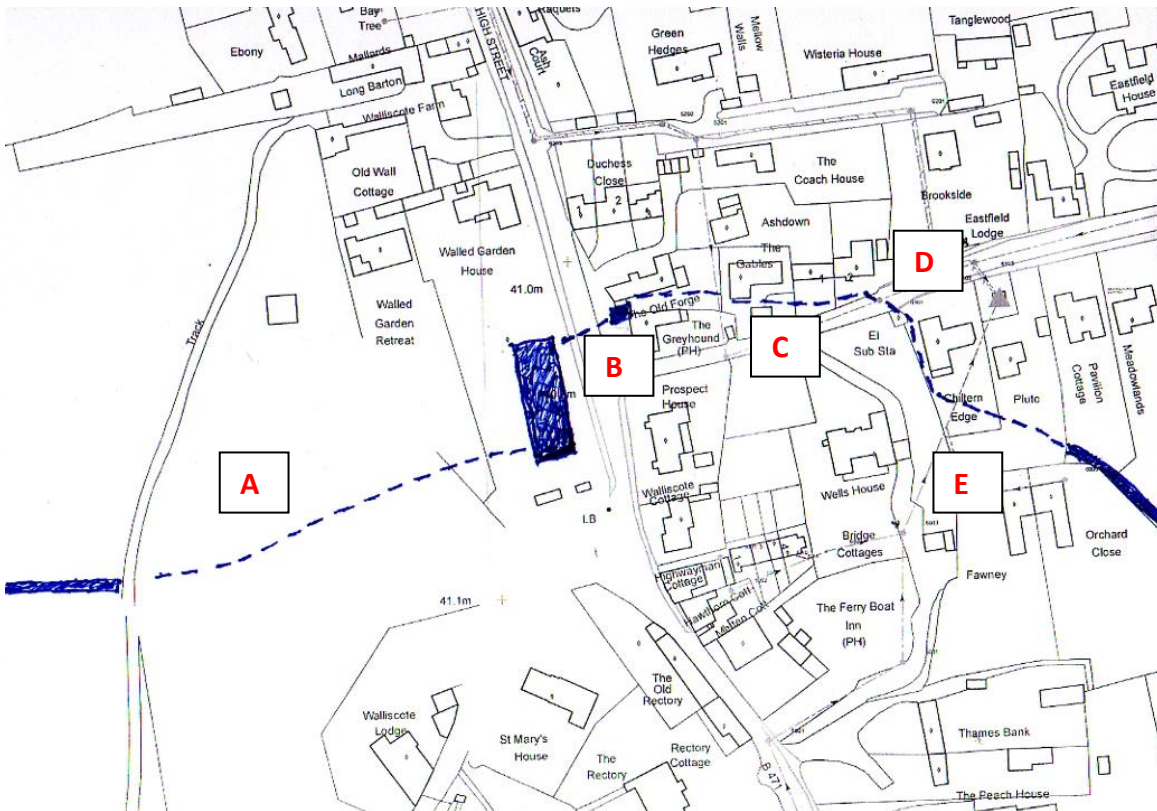
Figure 3 Village watercourse - culverted sections shown as dashes. Open water is solid fill

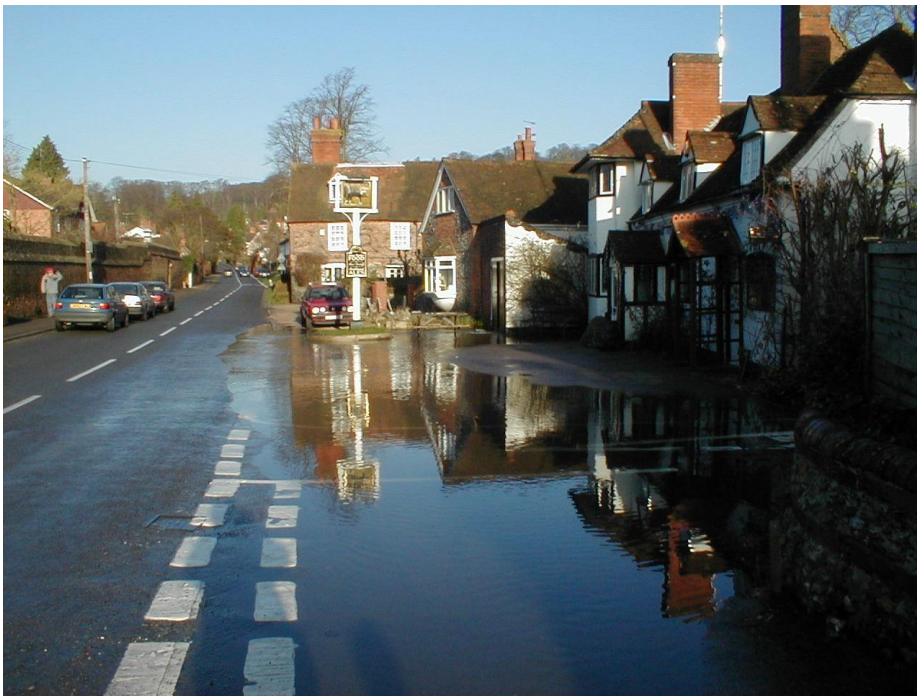
Culverts installed here less than 25 years ago have been the cause of two preventable flood events during Thames floods. Both were due to restrictive underground sections that caused water at above weir height to eject from a roadside drain in Eastfield Lane outside what is now Chiltern Edge (this drain would normally accept surface water and pass it via the village watercourse to the Thames)

- 1) 2003 flooding of the High Street (and flooding of The Greyhound)<sup>4</sup>. Sufficient water was ejected to enable the flow to crest the watershed outside The Gables and reach the High Street .see photo below taken after the peak. Hiding in plain sight is the failure of the High Street drains. (Was not investigated until 2021).

<sup>4</sup> This event triggered action by SODC to replace the privately installed underground section in 2004/5 – see Section 6

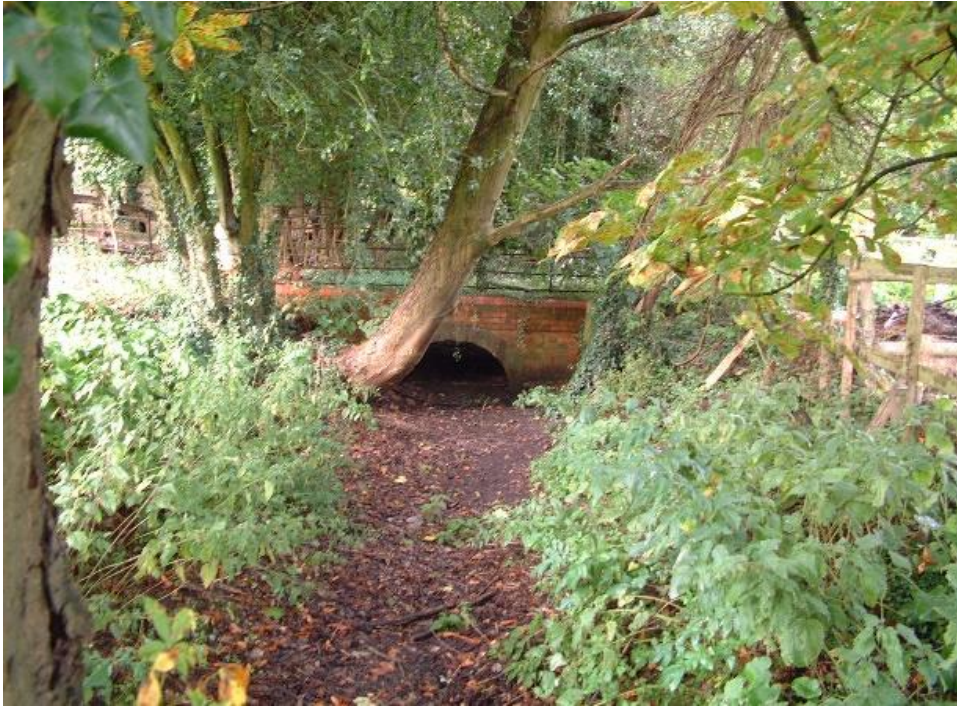
**Figure 11** The original line of the water course downstream of Pavilion Cottage. Note its width, about 5 metres, and a Victorian footbridge of the original Thames Bank estate. Photo taken September 2015. There is a puddle (groundwater table / Thames water level) in the low lying section under the bridge despite the dryness of the rest of the ditch.

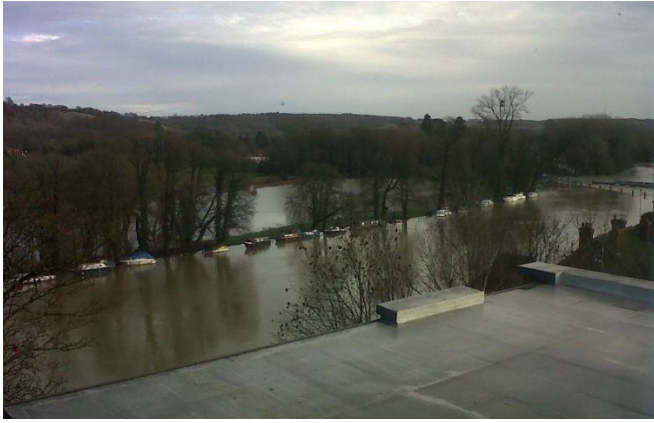
(At normal river height the northern bank of the Thames at Walliscote farm is effectively a canal embankment and when close to the Thames the river can be seen to be about 600 mm higher than water in an adjacent ditch.

Figure 9 Walliscote farm's levee, overtopped 2014

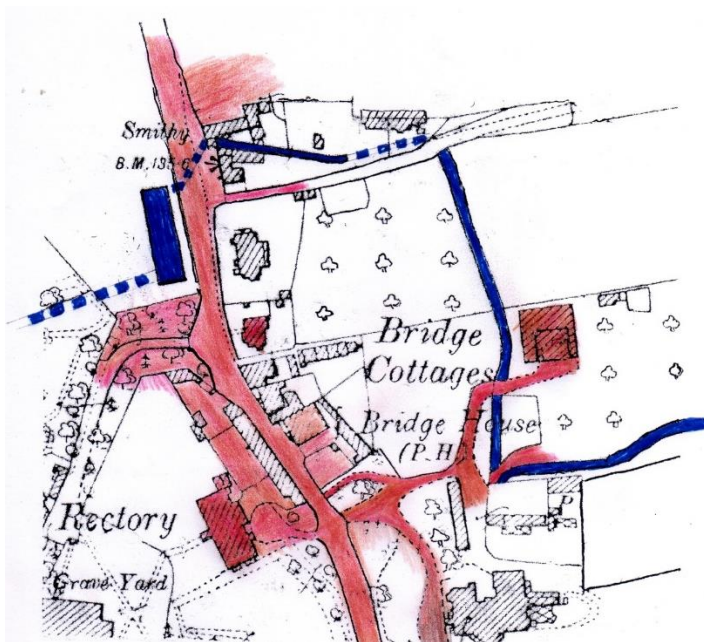
Figure 10  
General view of the scale

After the 1894 flood the High Street from north of The Greyhound to the toll bridge, plus parts of surrounding areas, were raised using material from the cutting that reduces the gradient<sup>12</sup> of Whitchurch hill above the war memorial. Chalk from there differs from the geology adjacent to the river (clay on gravel) so despite the surfaces today appearing to be no higher from infilling, the chalk becomes obvious when digging. See photo below of a circa 18" deep trench for an electricity cable.

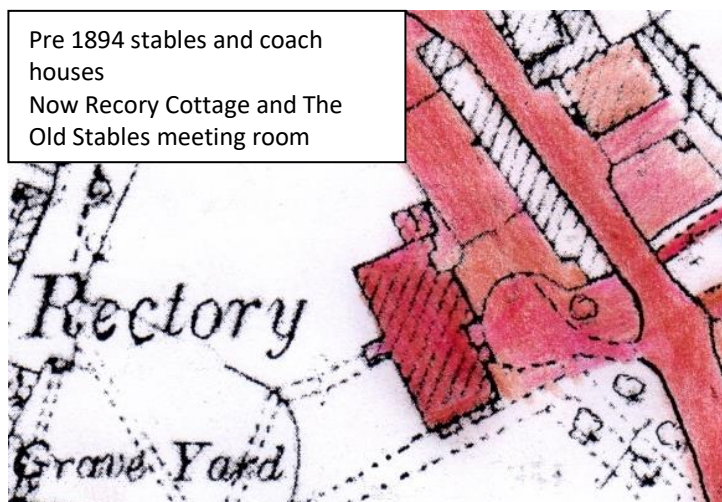
Figure 12

Today, this imposing building, but more importantly its set back location from a large forecourt looks "right". However this a modern development, built on a chalk plinth further west of the High Street post the 1984 flood. (The house is now named "The Old Rectory" following the building of new parsonage off Church Drive in 1999).

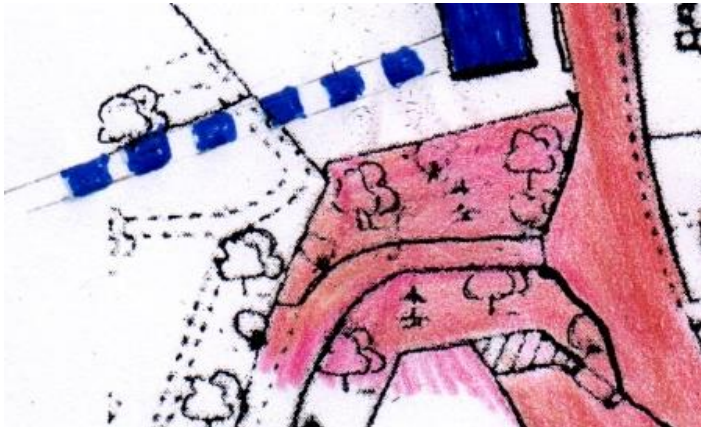
Figure 13 Church Drive entrance

The two<sup>15</sup> curved brick entrance walls that form the entrance of Church Drive give a clue to the pre 1894 land level, but this is hiding in plain sight as there is no obvious declination along Church Drive itself.

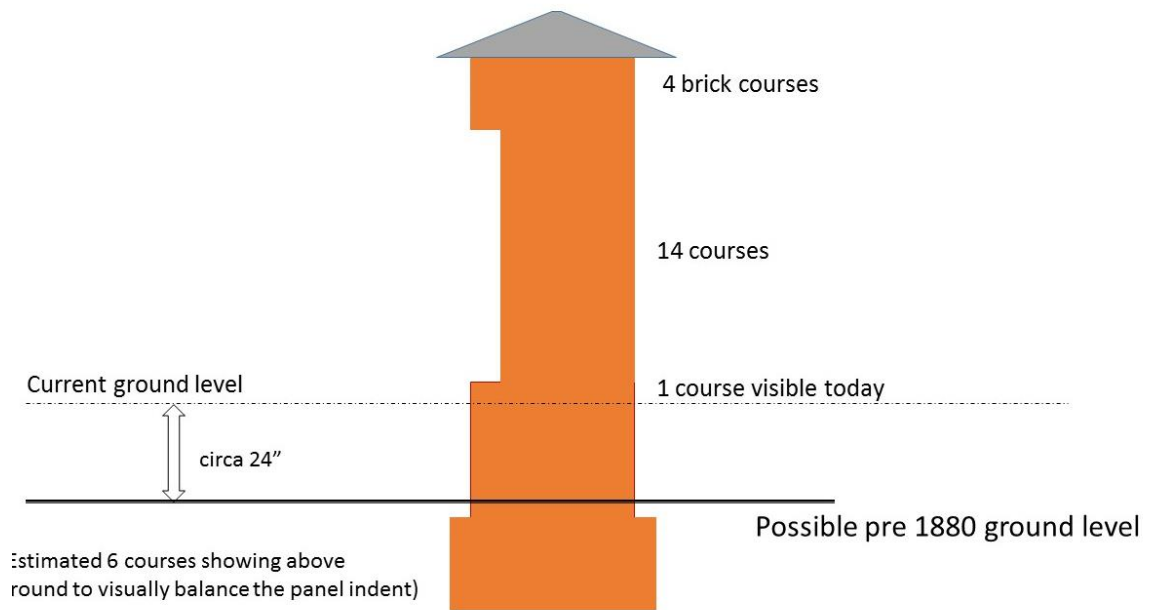
Figure 14. Church Drive entrance's recessed brick panels

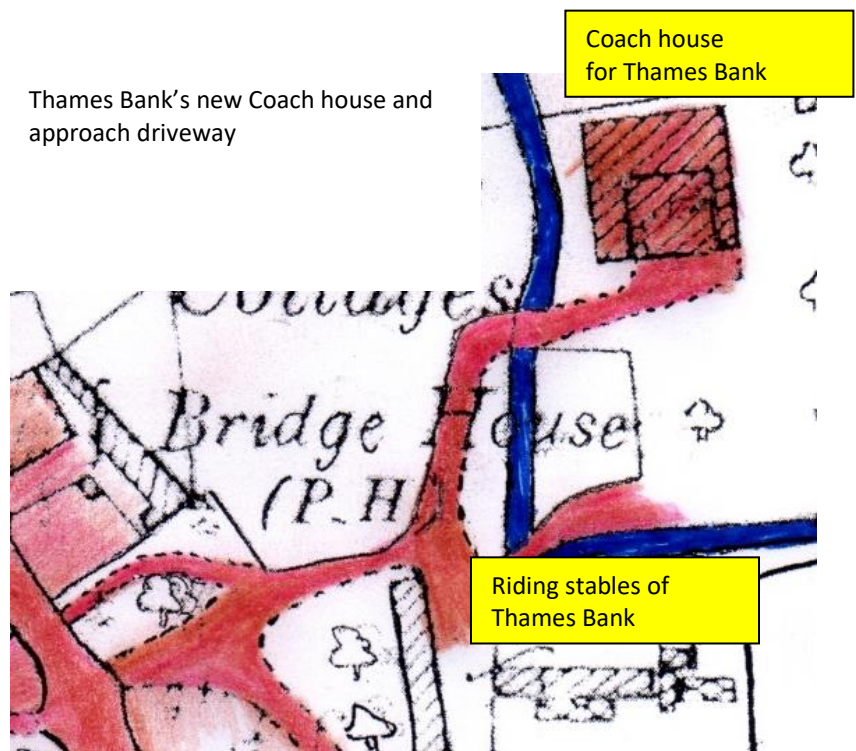
The coach house / forge / stabling and coachman's accommodation built for Thames Bank post 1894, (now Fawney and Orchard Close), along with the approach drive are on a chalk bed about 12" thick. This became apparent when digging a trench for an electricity cable

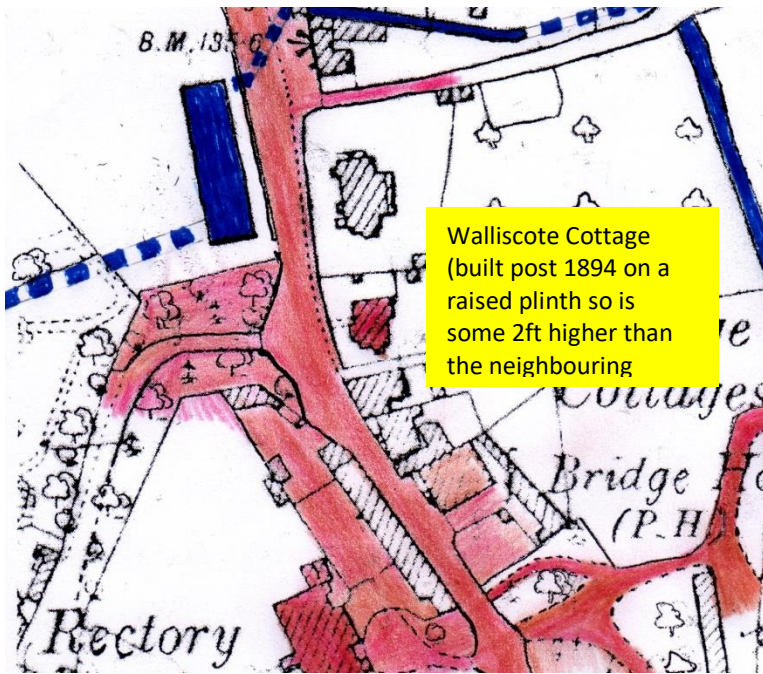
Walliscote Cottage  
(built post 1894 on a  
raised plinth so is  
some 2ft higher than  
the neighbouring

Hawthorn Cottage, Highwayman Cottage, (and Bridge Cottages behind) along with Prospect House are pre 1894 as they are below the road surface, whereas Walliscote Cottage is obviously post 1894 and is significantly above.

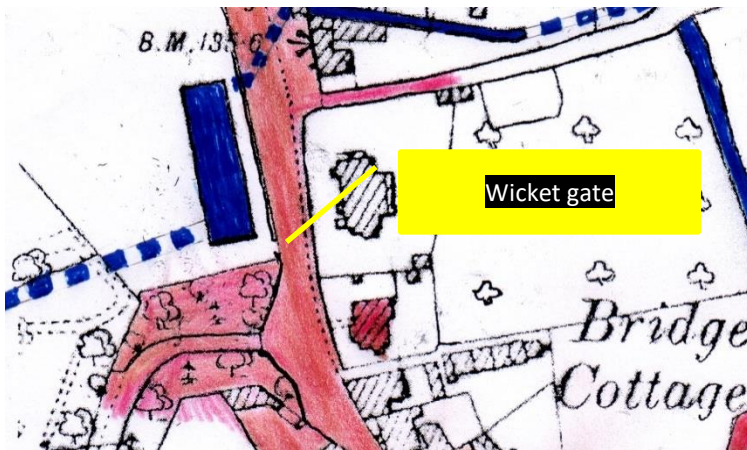
Wicket gate

An unintended consequence of raising the High Street has been to accentuate flash flooding in The Greyhound bowl because the higher road surface removed an escape path for surface water into the village watercourse via the pedestrian gateway of The Walled Garden House and into the pond there which is part of the village watercourse, (the iron gate opposite Walliscote Cottage).

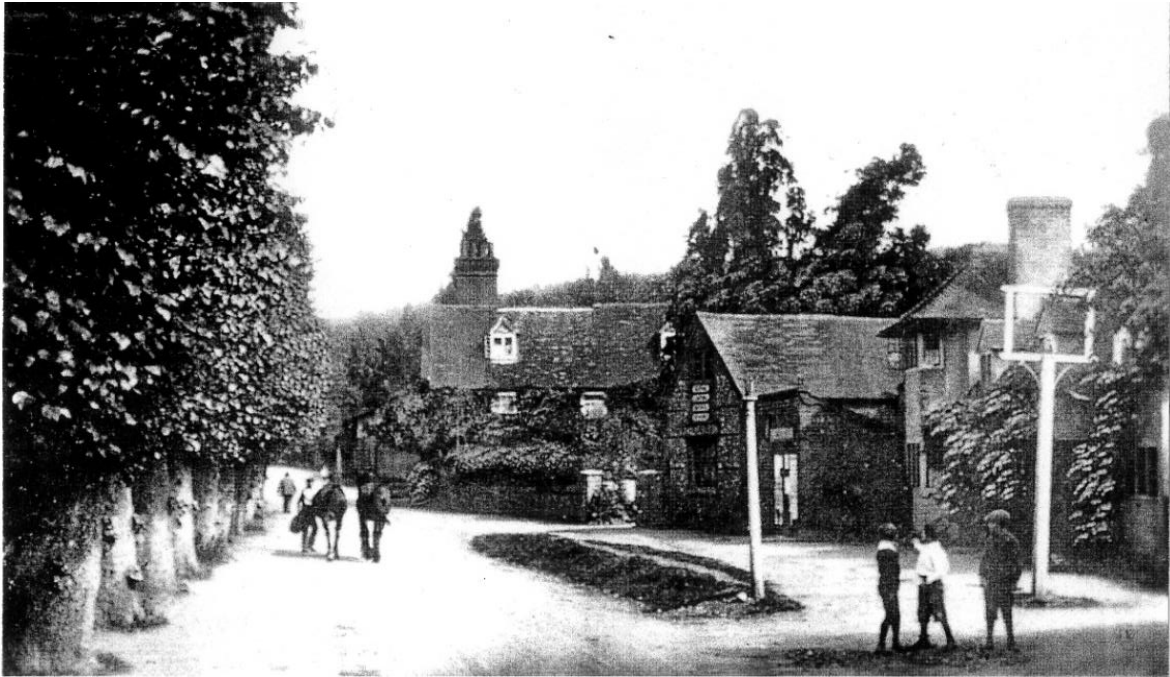
Figure 15 Pre 1894 photo of The Greyhound

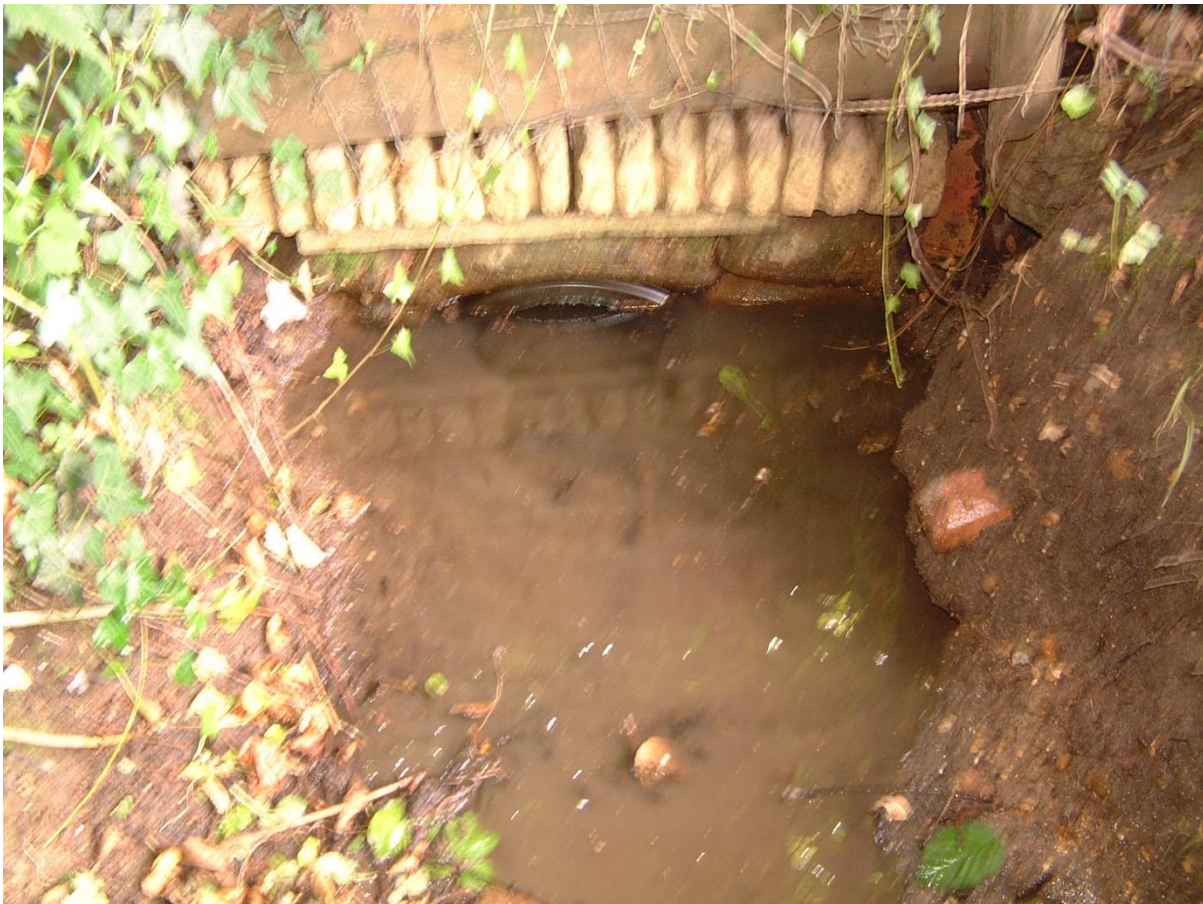
After the 2014 event, once The Thames had dropped to its normal level, a high water table remained visible in the ditch in Pavilion Cottage's garden, see photo. The lying water was high enough to cover the most of the exit of the 450 mm dia culvert extended from the earlier SODC installed culvert.

Failure to maintain a gradient to the Thames once the flood had receded is significant factor in lowering the local water table. I.e., if the downstream ditch all the way to the Thames was lowered by circa 300 mm there would not be lying water in the culverts south of Eastfield Lane, with corresponding lowering of the ground water table in the immediate vicinity.

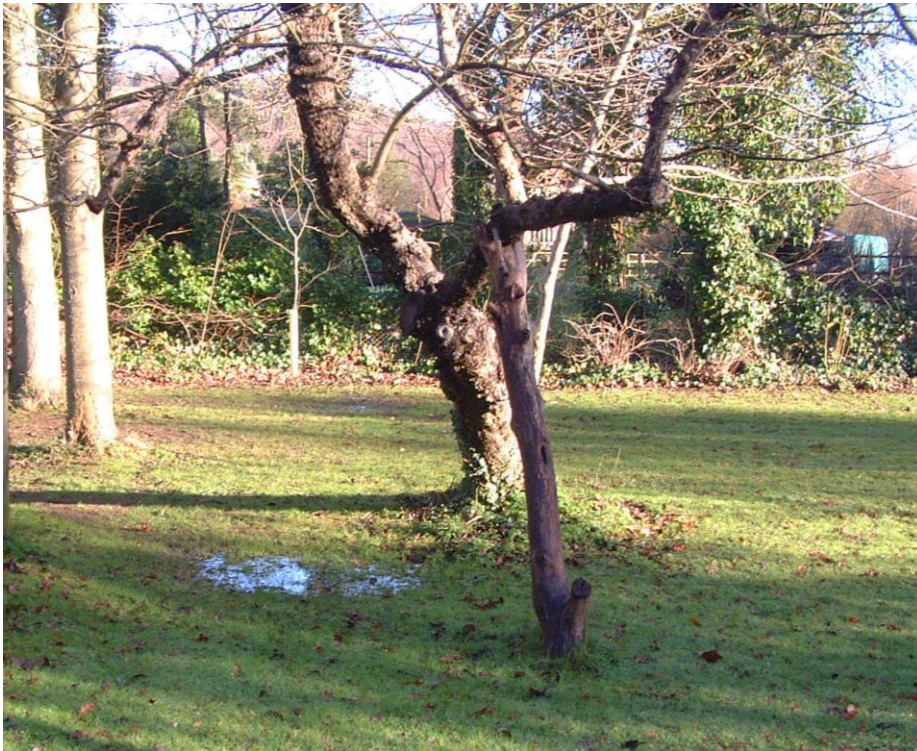
East of the High Street the underlying geology is different. Rising groundwater appears as puddles in low lying areas following the downstream Thames height compounded by subterranean flow from higher parts of the village after long wet periods (as in Jan / Feb 2021 when puddles appeared in front gardens of properties south of Eastfield Lane i.e. puddles appearing in land higher than the village watercourse)

**Figure 21 Thames appearing as puddles in lawn 2014**

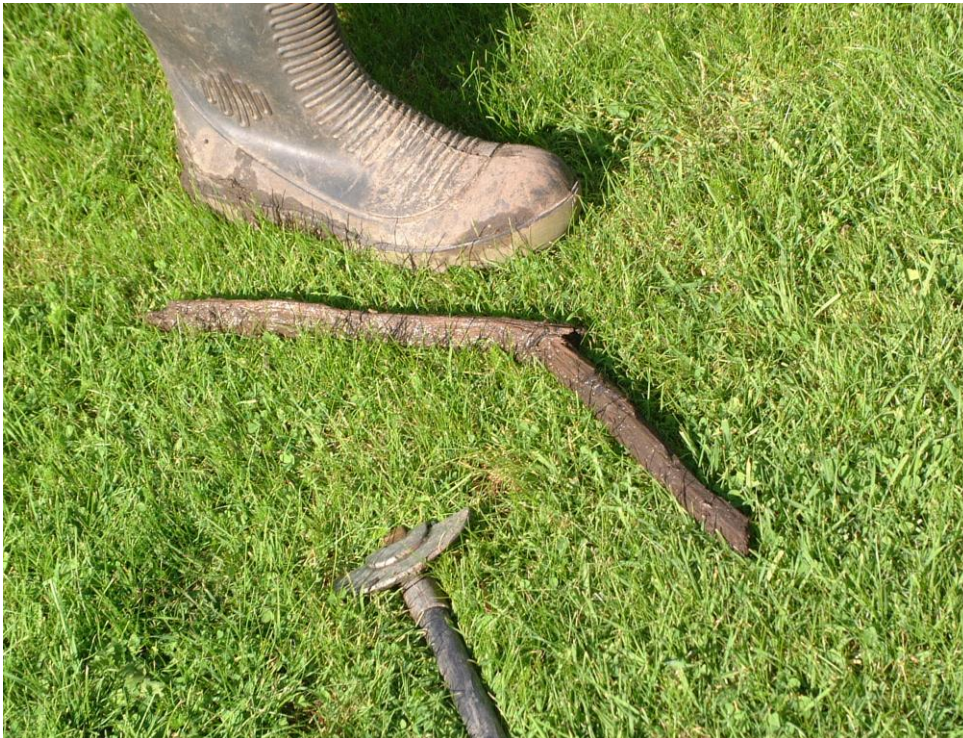
Insert sketch of rear of propertieswIn September 2015, taking advantage of a long dry spell that further lowered the water table which allowed access to the culveet exit from the ditch in Pavilion Cottage, a partial blockage was found some two metres into the culvert from its discharge to the ditch. This was cleared using drain rods, working from Pavilion Cottage's garden.

A possible cause of this blockage was a piece of chestnut paling fence found jammed amongst the leaf litter there. This could have floated in and become wedged. Due to the high local water table even at that time in mid summer the culvert had about 70 mm of standing water.

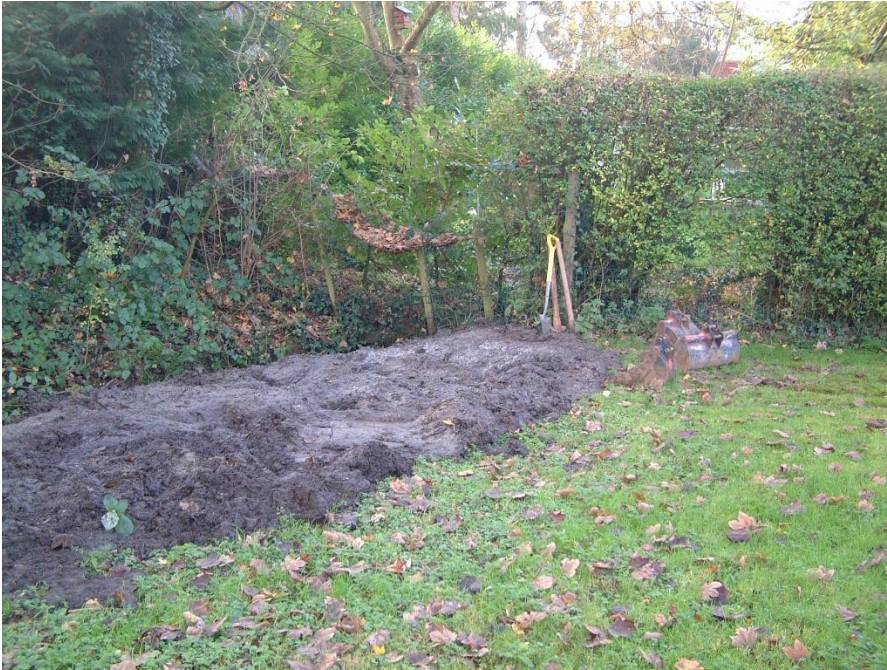
The open ditch from the culvert exit at Pavilion Cottage to the rear garden of the adjacent property, Meadowland, was subsequently cleared later in 2014 and a silt trap dug at the culvert exit.

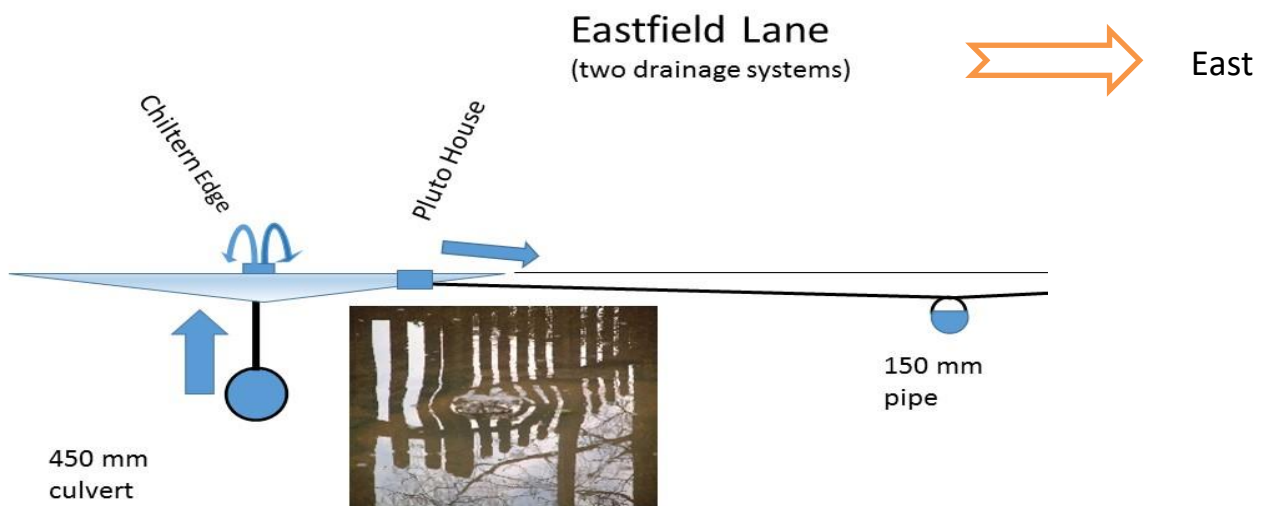
Surface water rose from one drain, and went down the next (photo)

In reality, there are only two effective road drains in Eastfield Lane and one of these is connected to a culvert which can, if restricted, result in a back flow of above weir height water into the road. (as happened in 2003 and 2014)

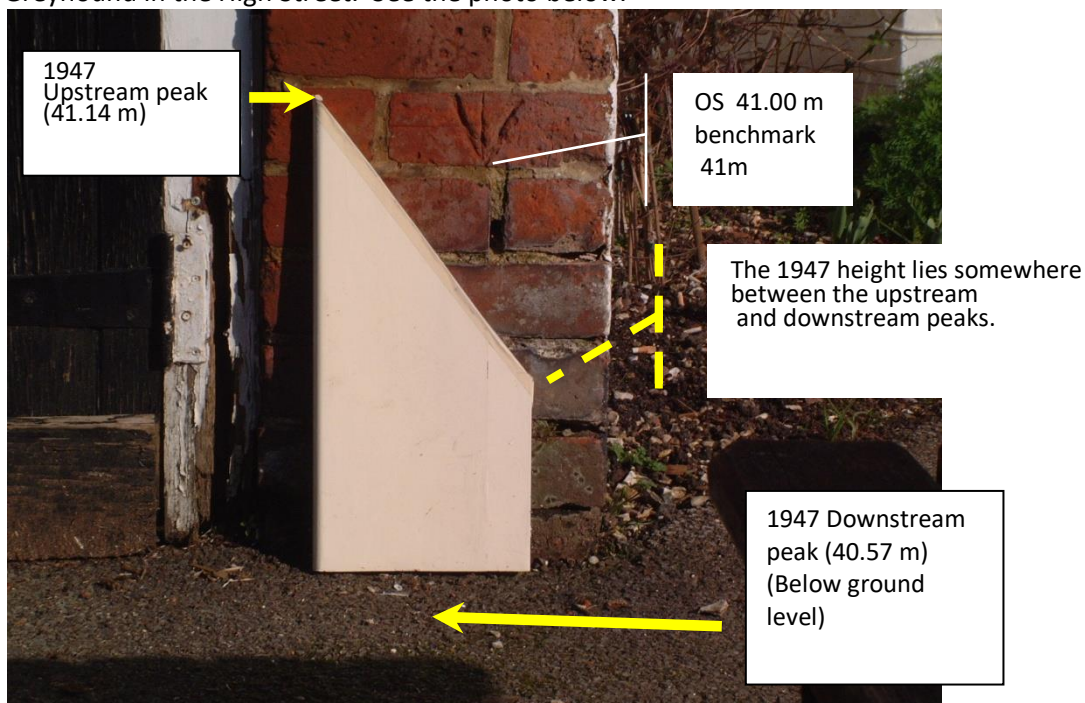
Figure 2 – Benchmark at The Greyhound.

Fig 2 above is an attempt to gauge where the water level could have come to in 1947. It could not have been lower than the downstream recording, nor higher than the upstream. An assumption that it was somewhat midway is not unreasonable.

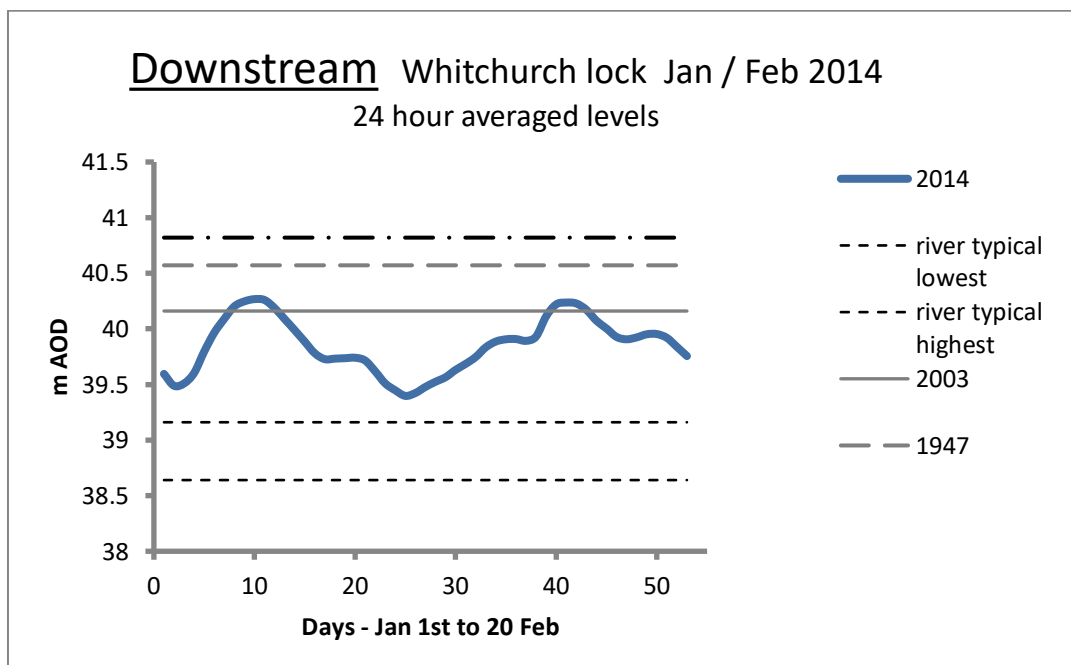
**Figure 16 - River levels - Downstream Jan / Feb 2014**

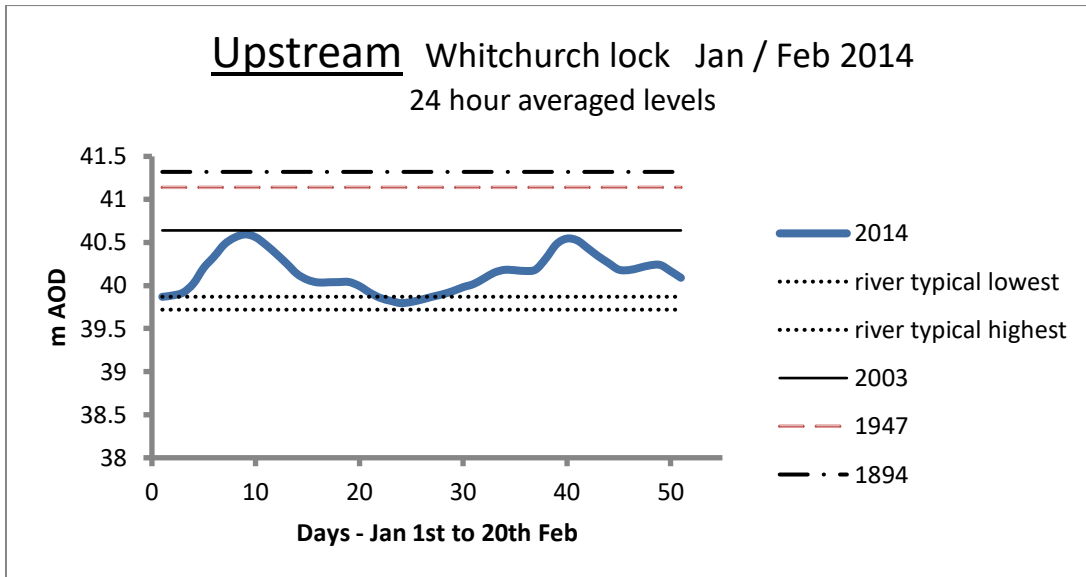
Figure 17 - River levels - Upstream Jan / Feb 2014

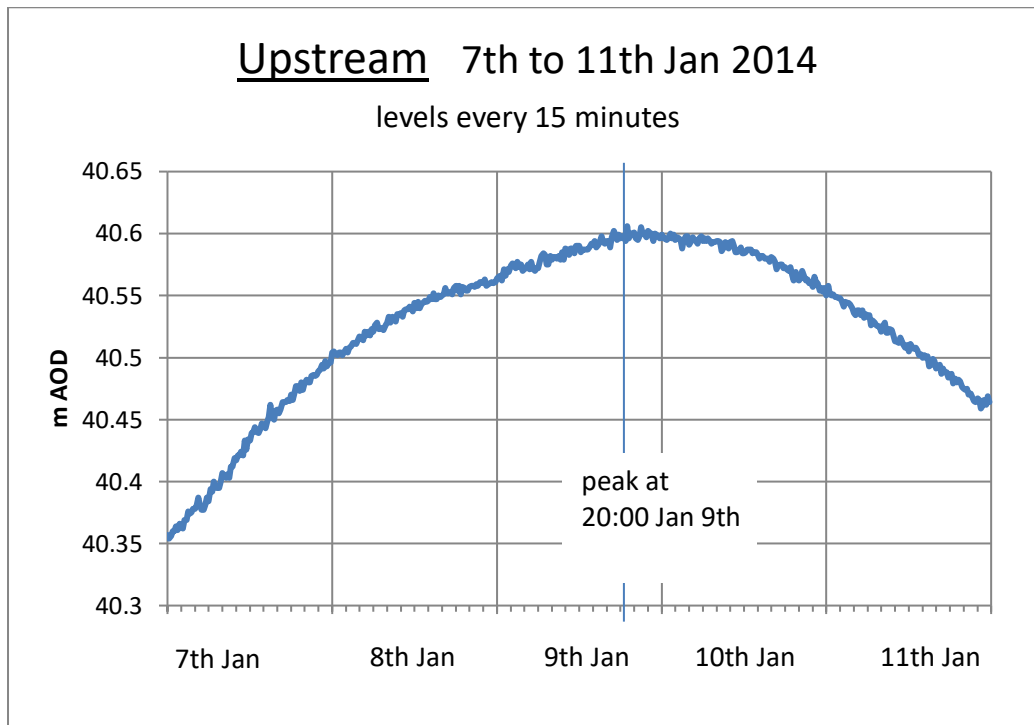
Figure 19 - Detailed River levels - Upstream 7 - 11 Jan 2014

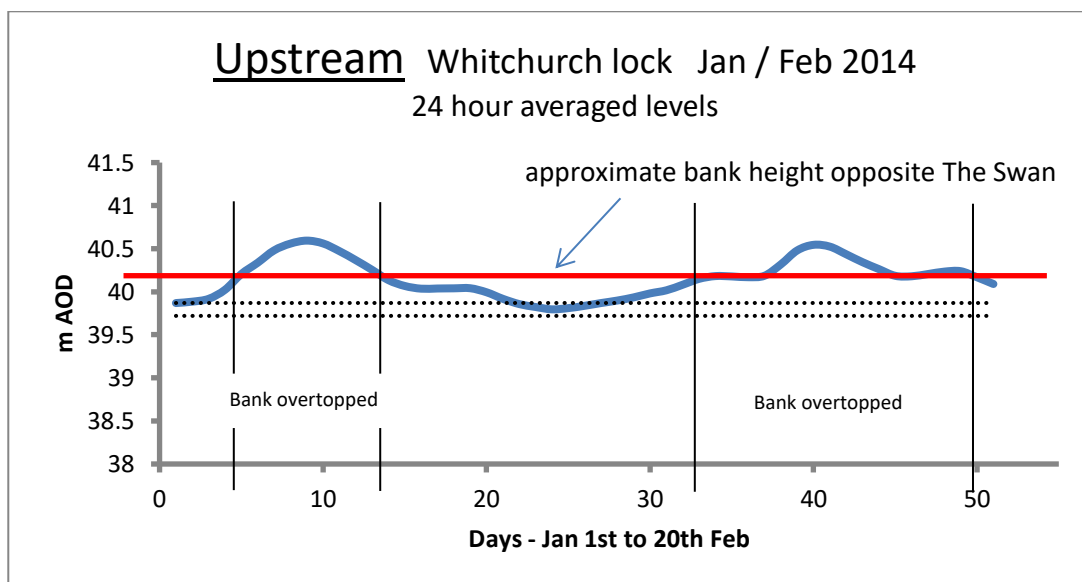
Figure 20 – periods of upstream bank overtopping. (dotted lines are the range of normal Thames height) dotted lines are range of normal Thames heights)

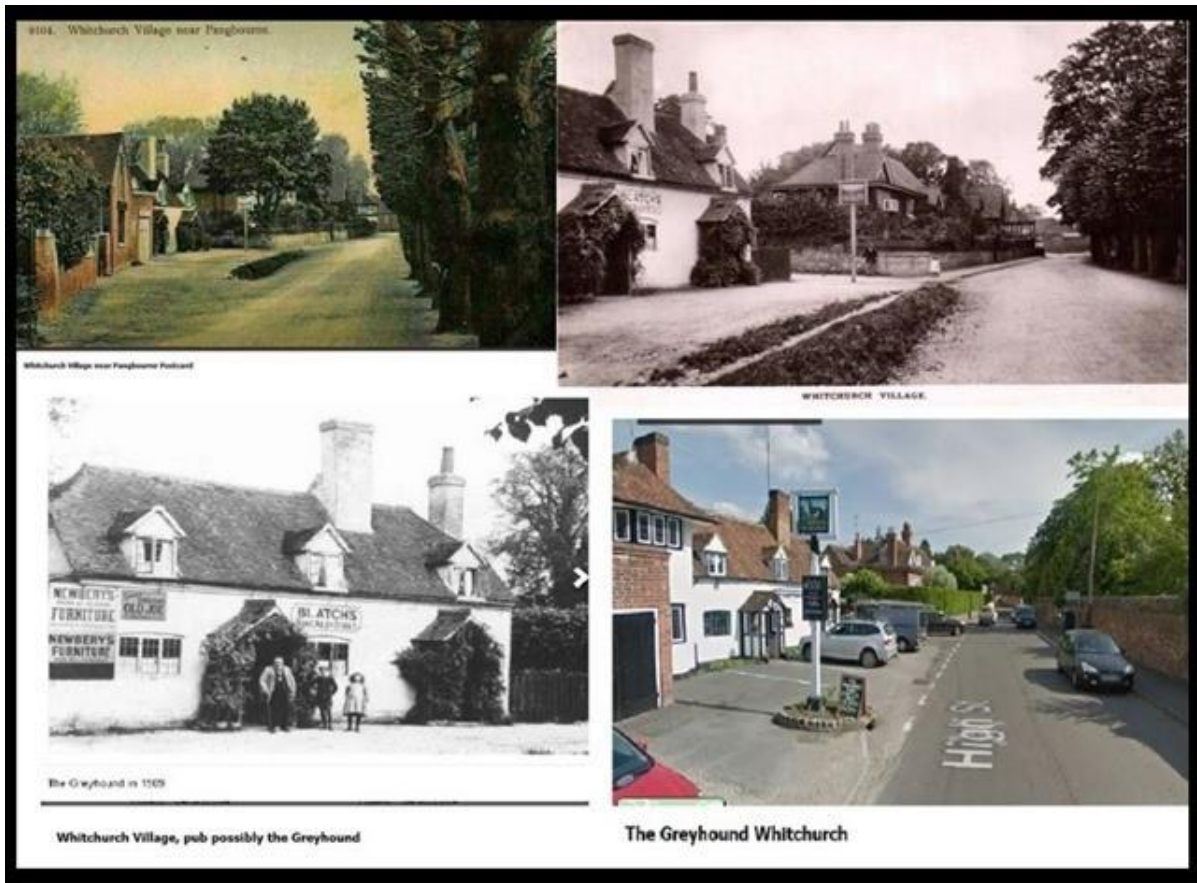
Old photos of The Greyhound

Note features in Fig 1, the white road, (pre tarmac), lack of kerb on the western side, (LH), and significantly higher ground outside The Smithy, the old fire station and The Greyhound. The two white pillars and entrance of what is now Duchess Close are at road level, and lower than what is now The Greyhound's car park.

Compare this scene with today's situation, fig 3, which is basically the opposite, namely the High Street is higher than The Greyhound's carpark by some 400 mm
