Hardwick Road Restoration Project

Phase 1

Authorship: **Whitchurch-on-Thames Habitat Study Group**

Date: 28th June 2012

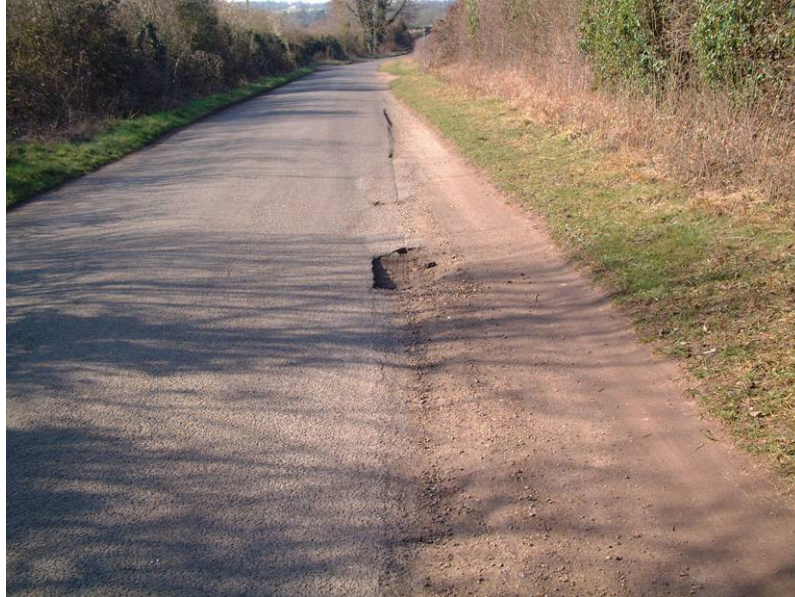
Additional passing places are being developed by passing traffic which is forcing a 2 way use of this road by using the verges to the detriment of the road surface and walkers. The size and number of the passing places has increased markedly in recent years.

Unofficial passing place with road edge damage. Note the shallow entrance angle caused by vehicles gradually moving over without stopping, rather than turning into a lay-by. This is typical of the unofficial lay-bys. Similar erosion is occurring on the embanked section where for example the concrete fire hydrant marker which was on the road edge near Shepherds Close was lost in 2010.

Restore the verges to make a consistent width, single carriageway road with clearly defined and maintained passing places at appropriate places. This would result in less risk of carriageway damage, safer pedestrian access to Hardwick Estate and traffic calming by single lane working.

OCC consultation on what can be done regarding road edge management (Highways and Conservation departments), and closely involving the local landowners in any site meetings.

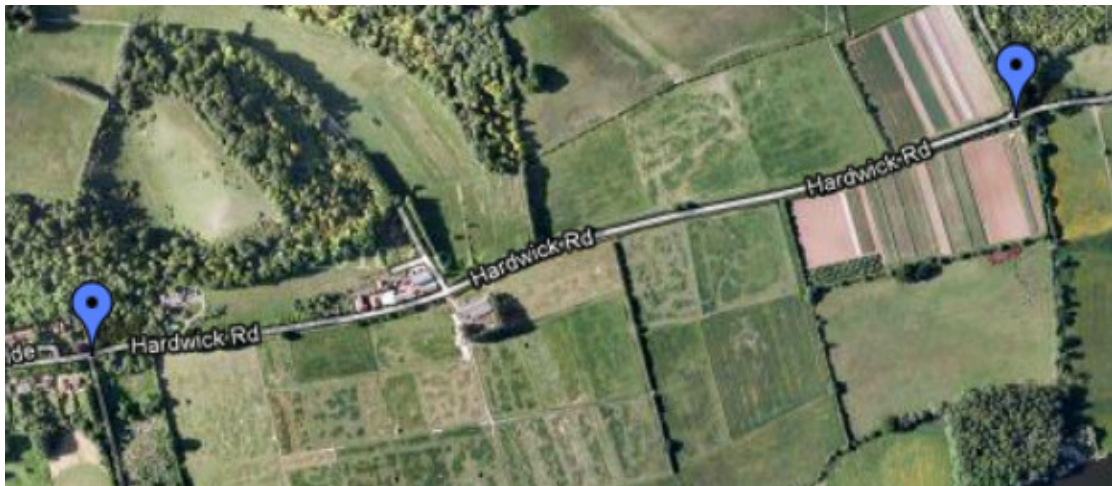
While the road is not busy from a traffic perspective, cars can travel quite fast and safety of walkers and cyclists is a concern, especially for families with children. Many people already use the verge to walk and run on, at least when cars are passing. There are some stretches of the road where trodden paths exist of varying quality but require walkers to cross from the north to south side several times.

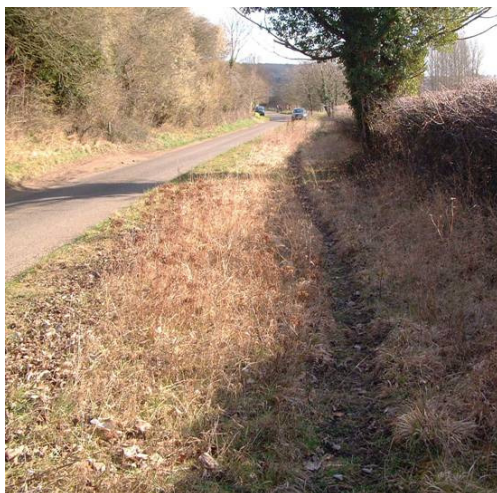
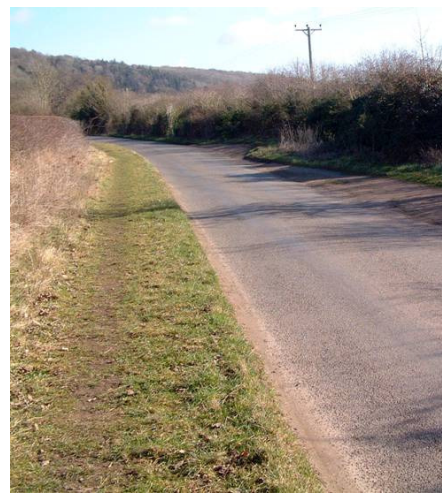
These photographs show sections of the uneven path on the south side and the more even-surfaced path on the north side. In future, it should be possible to walk on the south side for

the whole length of the road without crossing thus reducing wear to the more bio-diverse north verge.

It should be possible for walkers to stay on the south side verge for the full length of the road avoiding the need to cross the carriageway. At present, there are two main sections where it is not possible to walk on the south side due to the trees and shrubs growing close to the carriageway – these are the short stretch at the entrance to the village and the longer stretch near the Hardwick Estate gates.

A feasible and attractive solution to one or both of these sections would be to clear a ‘tunnel’ between the trees and make it even underfoot for safe walking.
